## Property Inspection Report

19139 Candletrail Dr., Spring, TX 77388

Date of Inspection: 10/5/2018 Time: 10:00 a.m.- 1:27 p.m.

Inspector: John Fish

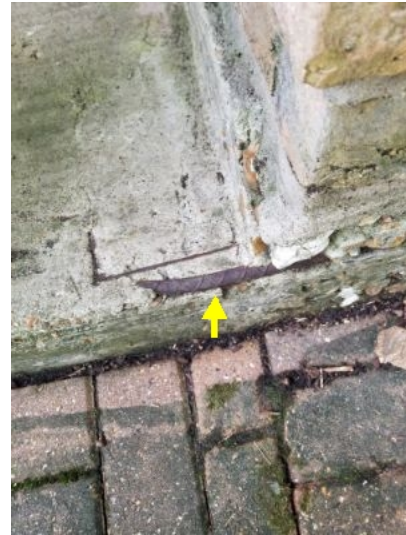
Observed damaged corners of the slab. "Corner pops" typically occur due to different thermal expansion rates between the wall and foundation. Because the foundation reinforcement does not extend into the corners, these areas are weaker than the surrounding masonry and crack under expansive pressure. These cracks are common and do not affect foundation performance

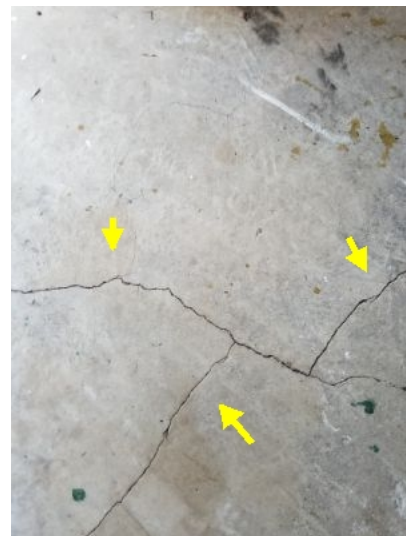
Cracking noticed in foundation at garage in areas and floor slopes recommend a foundation company evaluate the foundation at garage area may not be supporting the structure as intended.

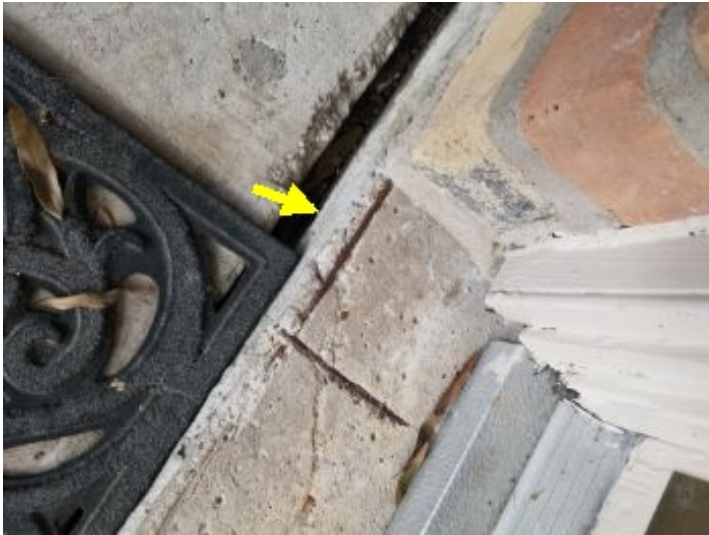
Exposed re barr at home in areas recommend foundation company evaluate and repair.

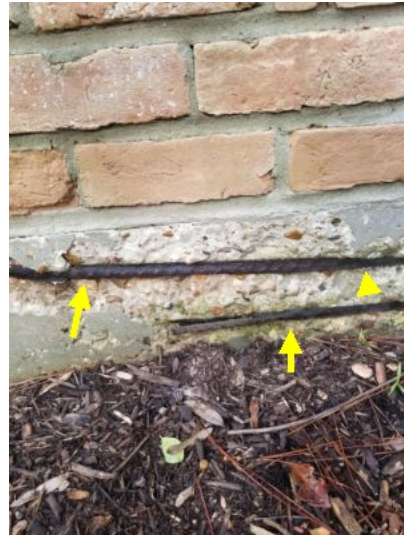
Exposed re barr at home in areas recommend foundation company evaluate and repair.

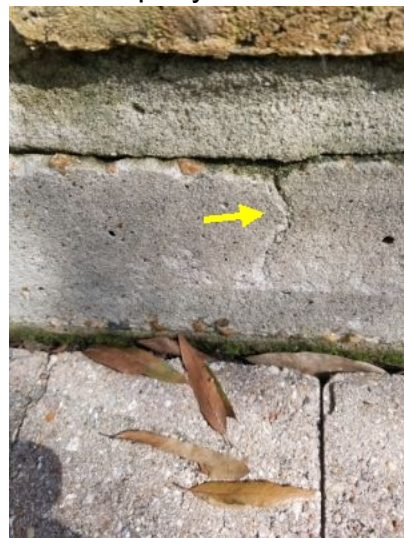
Observed hairline crack in foundation at home.

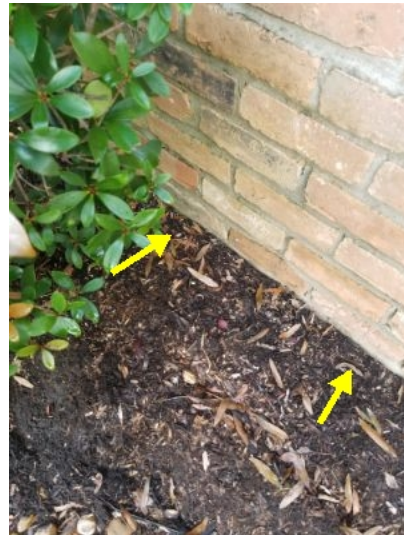
There are areas around the foundation that have high soil, Which can be conducive to termites and allow water/insects into home. Soil grade should typically be four to six inches below the top of foundation with a positive slop away from the foundation for proper drainage.

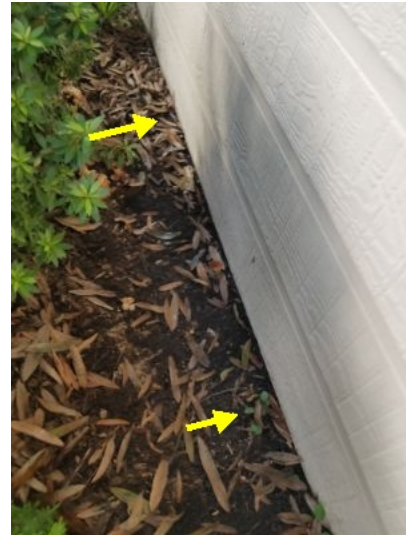
Extensive vegetation next to the home or growing on the home can promote moisture damage and wood deterioration to the siding and structure. It is recommended to keep all vegetation away from the home to allow proper ventilation between the home and vegetation • Wood form boards and /or stakes around foundation should be removed as they will tend to rot and may attract termites

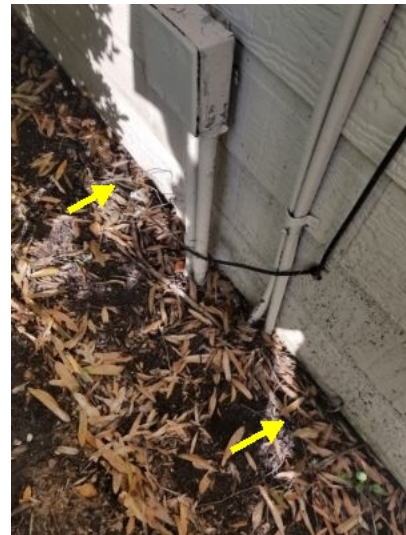
There are areas around the foundation that have high soil, Which can be conducive to termites and allow water/insects into home. Soil grade should typically be four to six inches below the top of foundation with a positive slop away from the foundation for proper drainage.

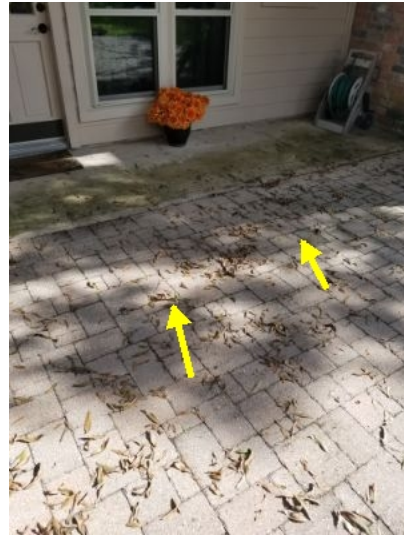
Soil grade and drainage patterns around some areas of house do not appear to properly direct water away from foundation to aid in controlling runoff water and could cause differential movement of the foundation or water penetration during heavy rains.( Back of home and back area of garage.)

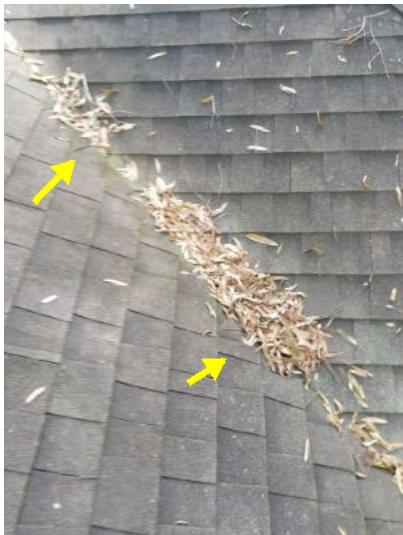
Recommend removing debris from roof areas.

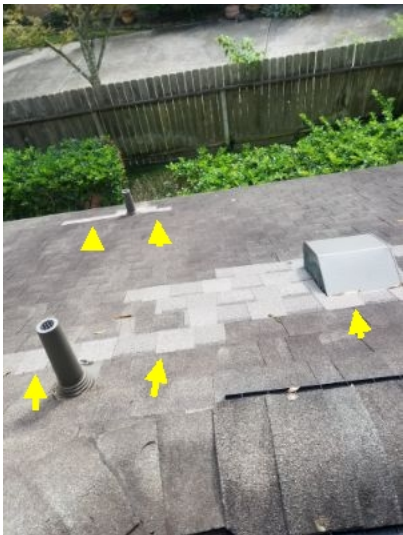
Damaged ridge cap shingles observed in areas.

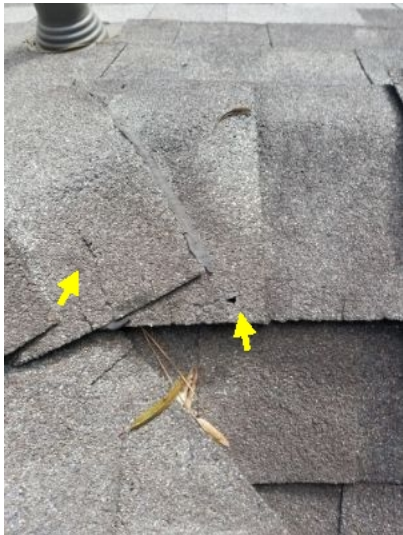
Damaged ridge cap shingles observed in areas.

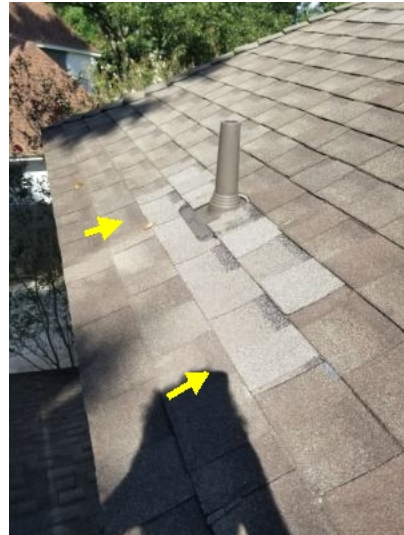
Observed repaired areas where newer shingles where installed in areas.

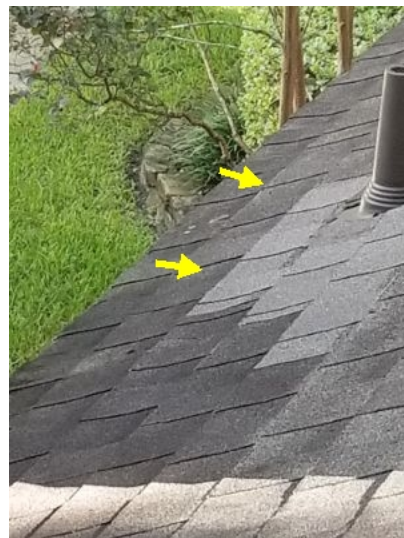
Observed repaired areas where newer shingles where installed in areas.

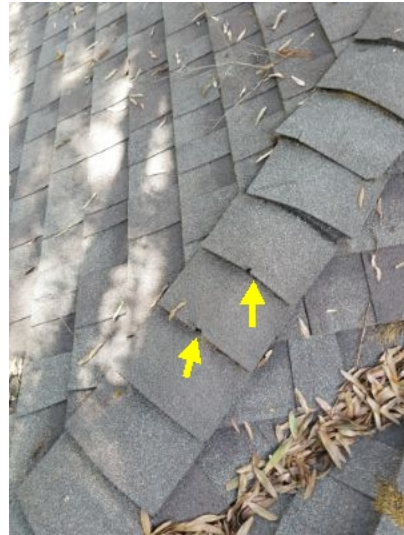
Damaged ridge cap shingles observed in areas.

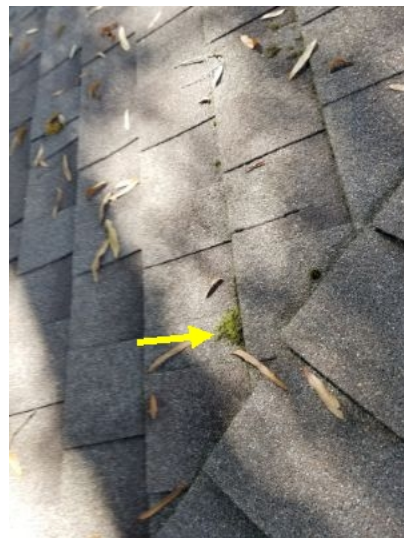
Observed moss growing on shingles in areas.

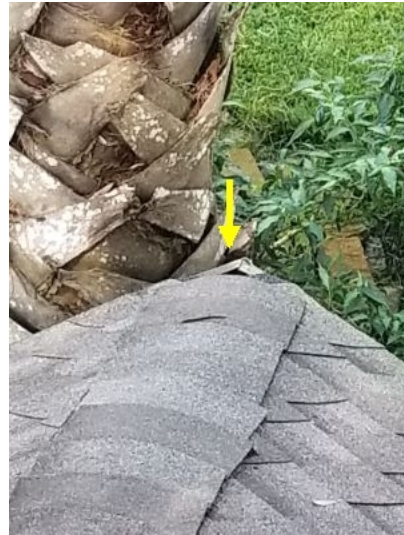
Missing ridge cap shingle at bottom of roof at front corner of garage.

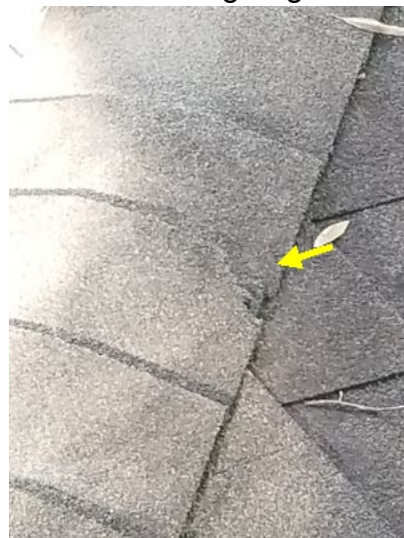
Damaged ridge cap shingles observed in areas.

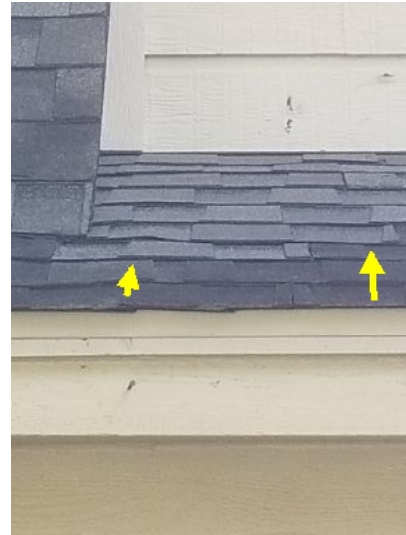
Observed repaired areas where newer shingles were installed in areas.

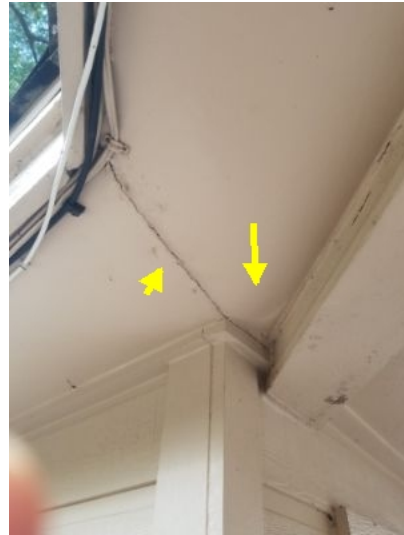
Observed moisture damaged soffits in more than one areas recommend contactor evaluate and repair.

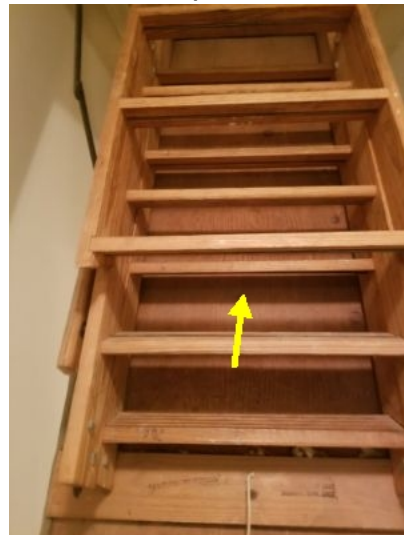
Missing fire blocking material at attic access pull down stairs.

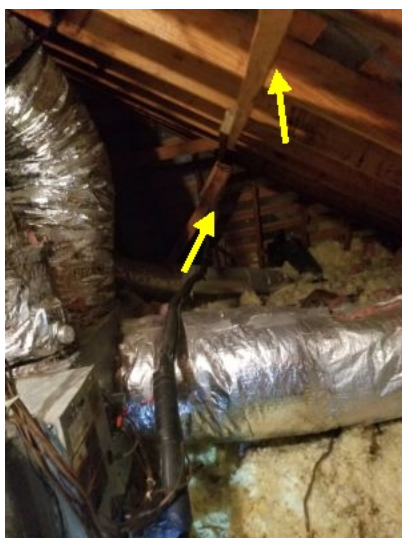
Missing purlin supports in areas.

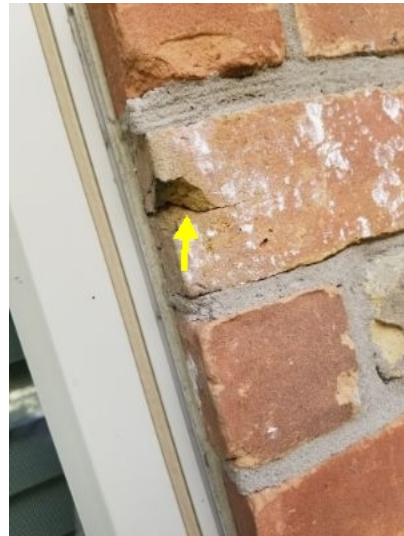
Damaged brick veneer in areas.

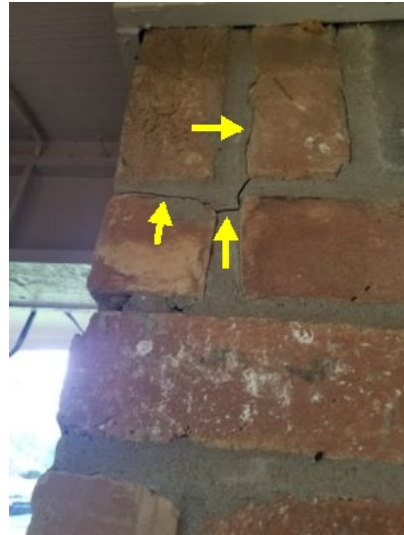
Observed mortar cracks in areas.

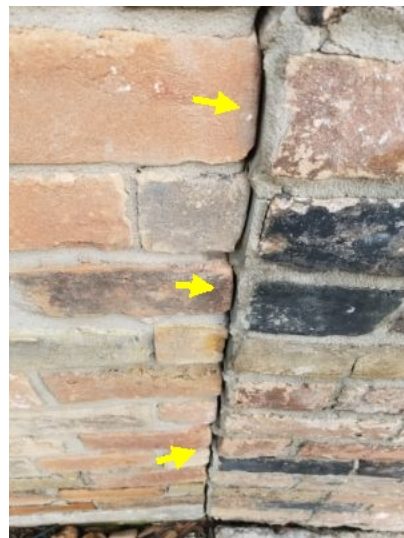
The brick wall at back of home attached missing mortar and separating from home,

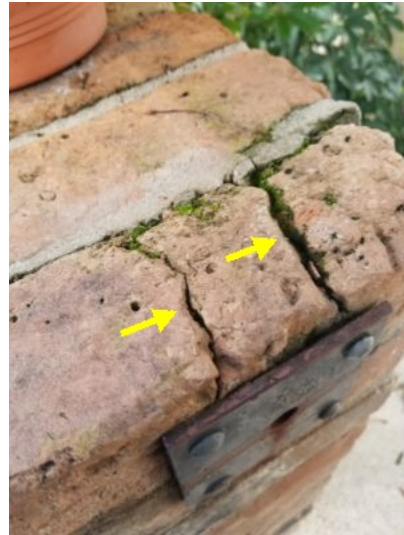
Cracks at brick wall in brick veneer at back of home for gate.

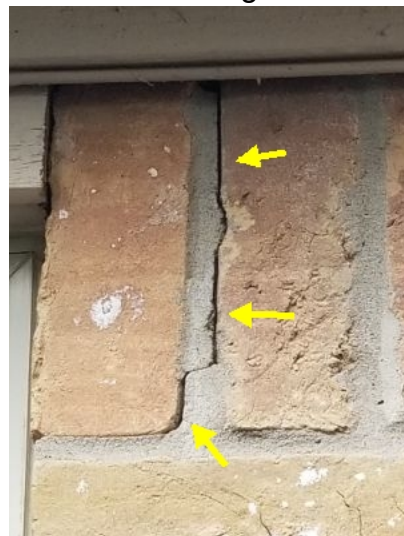
Observed mortar cracks in areas.

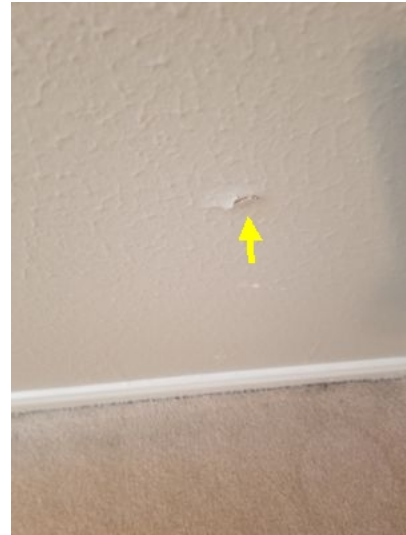
Hole observed at drywall upstairs back bedroom.

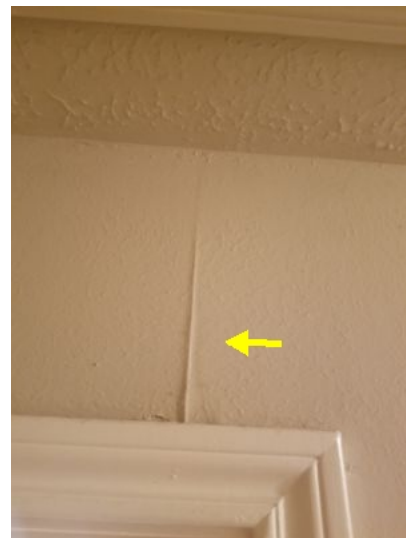
Cracks or repaired cracks observed in drywall in areas.

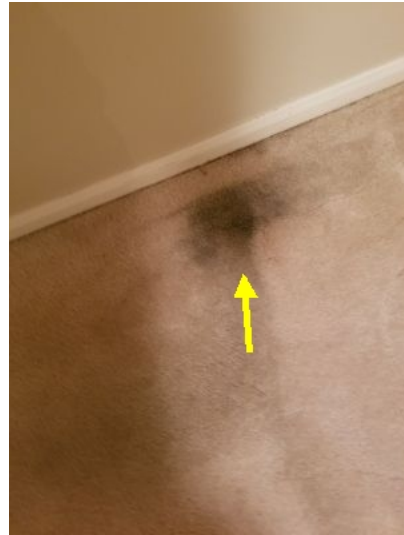
Observed stains in carpet in areas.

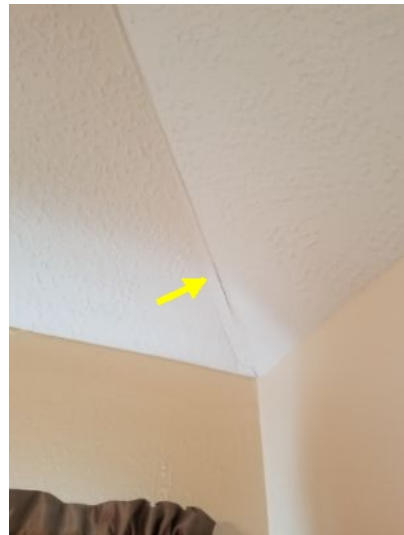
Cracks observed in drywall on ceiling

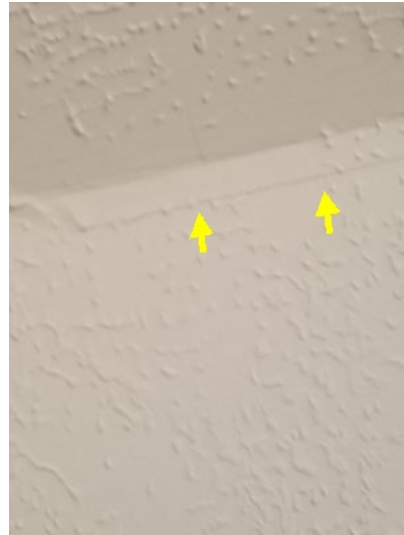
Cracks observed in drywall on ceiling

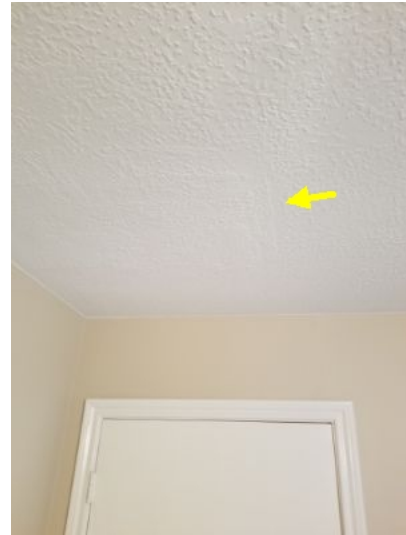
Patched areas on the ceiling

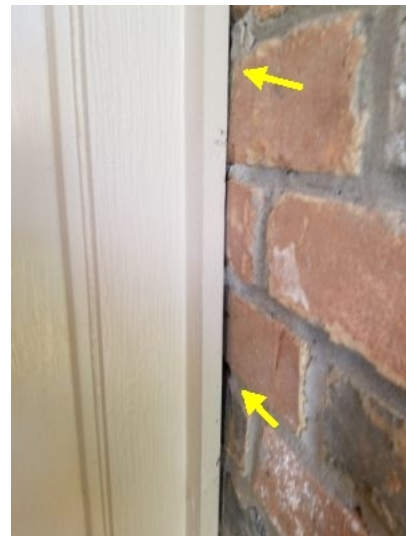
Observed some damage at back door jamb laundry room entry door.

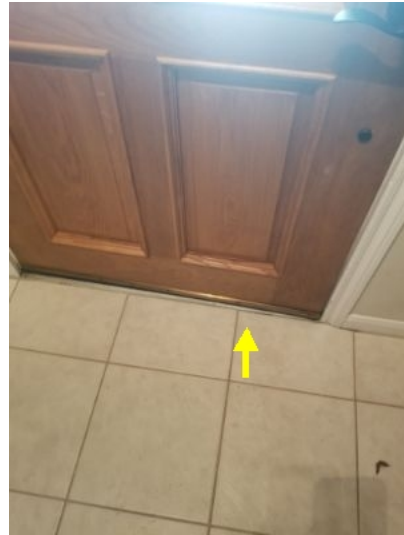
Front door sticks at threshold.

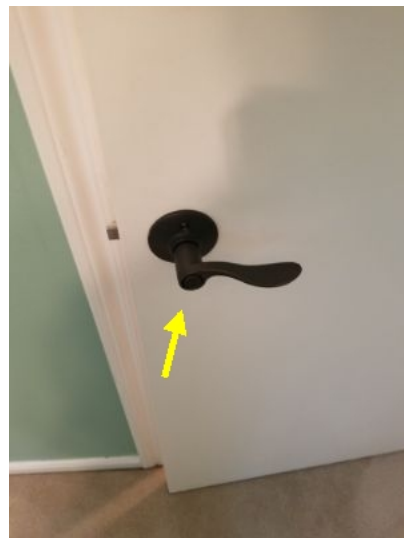
Loose door knob at upstairs right front bedroom (If viewed by facing home from street)

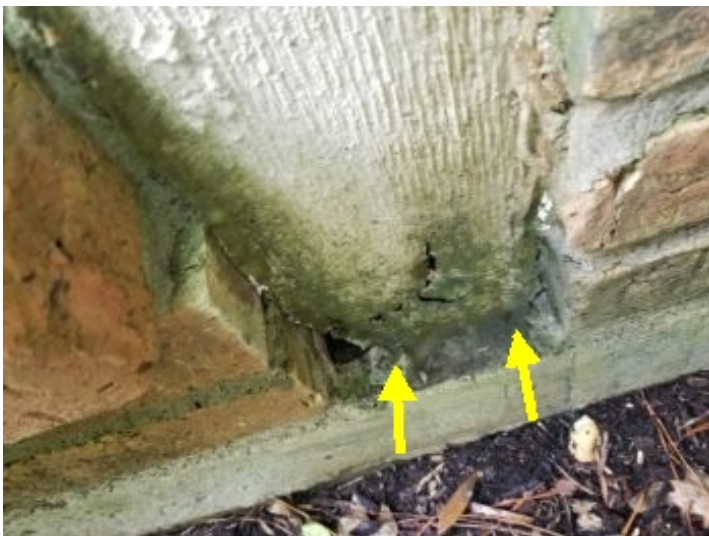
Wood rot observed at window trim at bottom of front windows. Recommend contactor evaluate and repair.

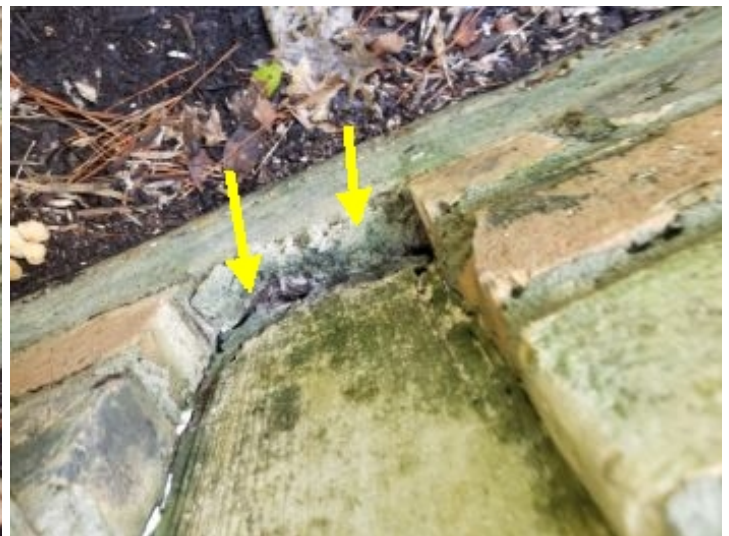
Wood rot observed at window trim at bottom of front windows. Recommend contactor evaluate and repair.

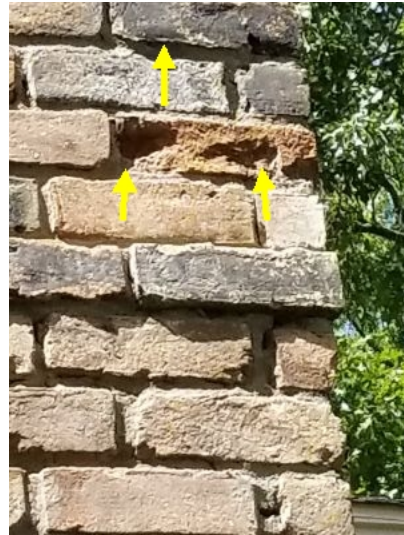
Observed damaged bricks and missing mortar at chimney at exterior areas.

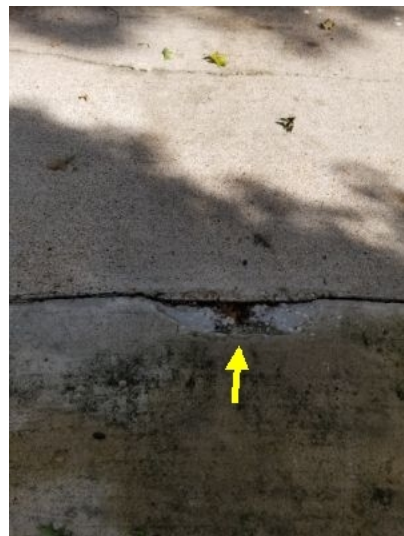
Damaged area at driveway.

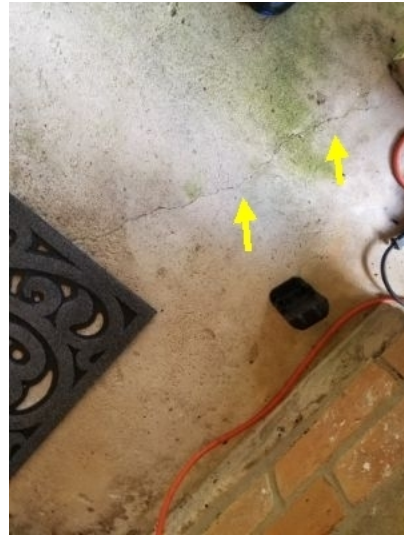
cracking seen on the front porch

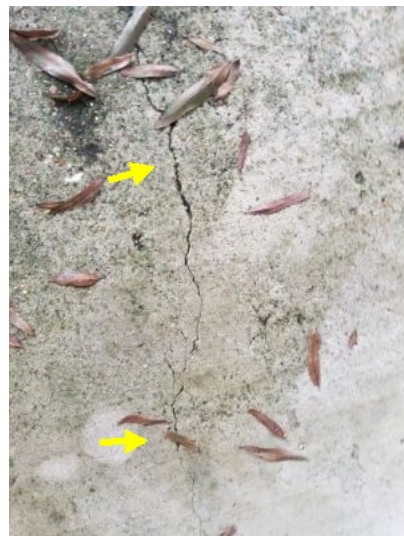
cracking seen on the patio

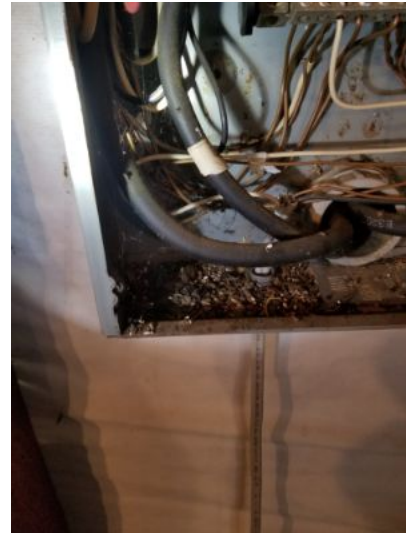
Rodent droppings present at panel.

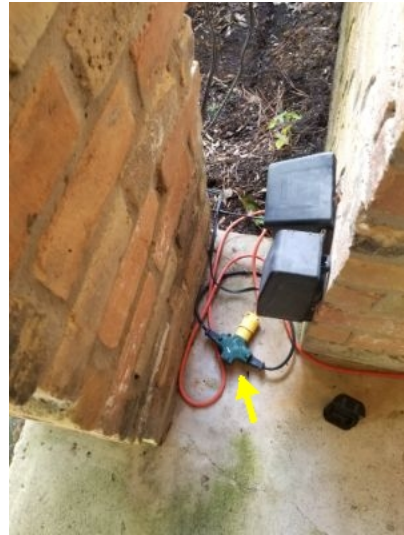
Extension cord being used as permanent wiring at exterior.

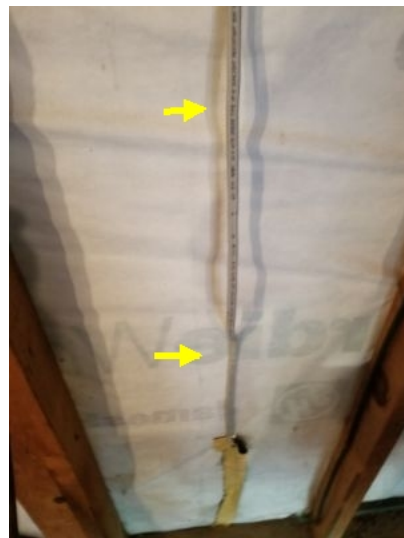
Wiring under 8' that's not in protective conduit at area of garage.

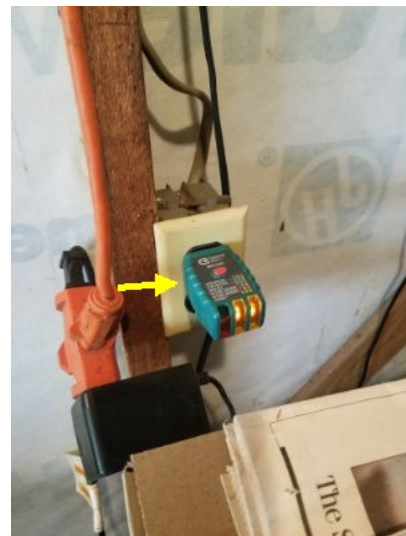
Not all outlets in hazardous locations are protected with GFCI circuitry as required by current standards. Observed one or more of the following required locations that are not GFCI protected: all bathrooms, all kitchen counter top and island outlets, all exterior outlets, garage outlets, etc. This condition is a recognized hazard and should be corrected by a qualified/licensed electrician. One or more outlets in the following locations were not protected: Not present at garage areas, Not present at all kitchen areas, Not present at all exterior areas, Missing at bar area, Not present at all bathrooms missing at half bath, not present at all required areas in laundry and at dishwasher now required as of 2014,

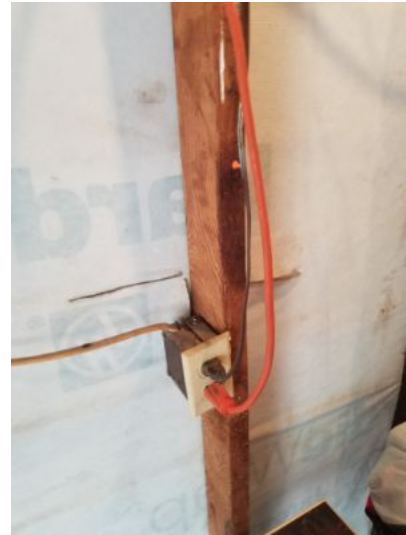
Extension cord being used as permanent wiring at garage area.

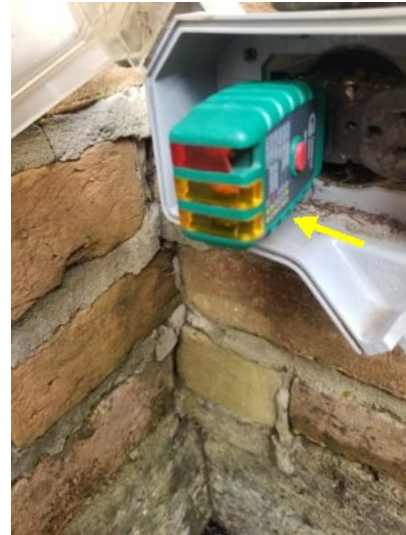
Not all outlets in hazardous locations are protected with GFCI circuitry as required by current standards. Observed one or more of the following required locations that are not GFCI protected: all bathrooms, all kitchen counter top and island outlets, all exterior outlets, garage outlets, etc. This condition is a recognizee hazard and should be corrected by a qualified/licensed electrician. One or more outlets in the following locations were not protected: Not present at garage areas, Not present at all kitchen areas, Not present at all exterior areas, Missing at bar area, Not present at all bathrooms missing at half bath, not present at all required areas in laundry and at dishwasher now required as of 2014,

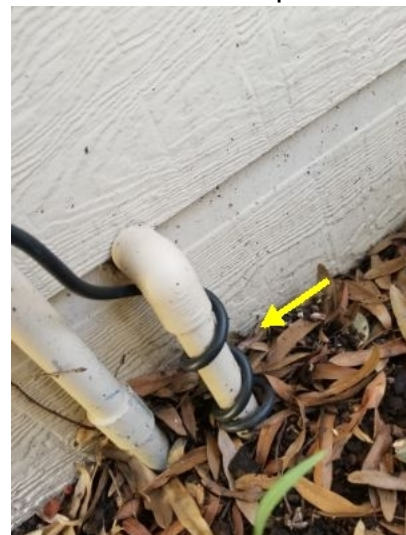
Wiring under 8' that's not in protective conduit at exterior areas.

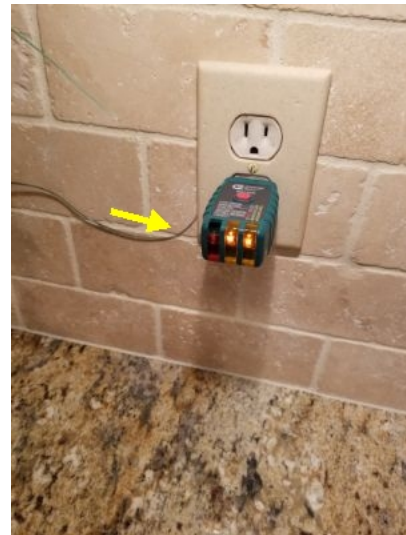
Not all outlets in hazardous locations are protected with GFCI circuitry as required by current standards. Observed one or more of the following required locations that are not GFCI protected: all bathrooms, all kitchen counter top and island outlets, all exterior outlets, garage outlets, etc. This condition is a recognizee hazard and should be corrected by a qualified/licensed electrician. One or more outlets in the following locations were not protected: Not present at garage areas, Not present at all kitchen areas, Not present at all exterior areas, Missing at bar area, Not present at all bathrooms missing at half bath, not present at all required areas in laundry and at dishwasher now required as of 2014,

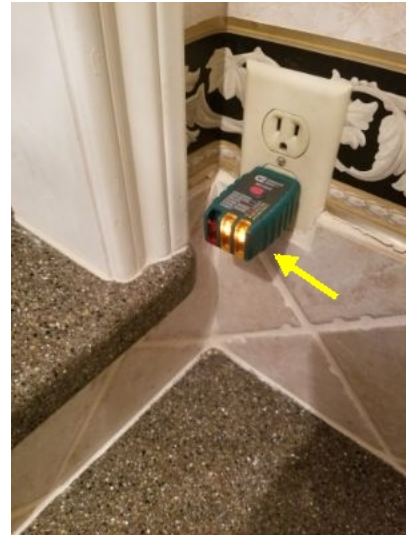
Not all outlets in hazardous locations are protected with GFCI circuitry as required by current standards. Observed one or more of the following required locations that are not GFCI protected: all bathrooms, all kitchen counter top and island outlets, all exterior outlets, garage outlets, etc. This condition is a recognizee hazard and should be corrected by a qualified/licensed electrician. One or more outlets in the following locations were not protected: Not present at garage areas, Not present at all kitchen areas, Not present at all exterior areas, Missing at bar area, Not present at all bathrooms missing at half bath, not present at all required areas in laundry and at dishwasher now required as of 2014,

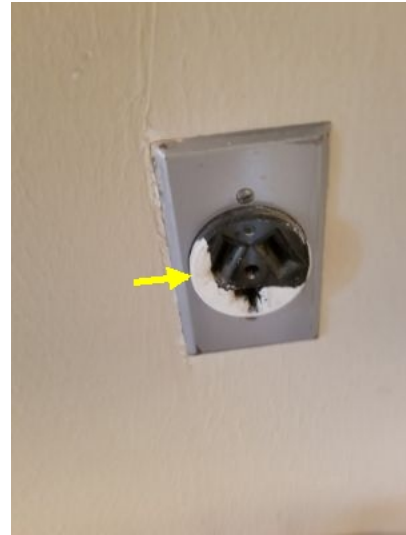
Not all outlets in hazardous locations are protected with GFCI circuitry as required by current standards. Observed one or more of the following required locations that are not GFCI protected: all bathrooms, all kitchen counter top and island outlets, all exterior outlets, garage outlets, etc. This condition is a recognizee hazard and should be corrected by a qualified/licensed electrician. One or more outlets in the following locations were not protected: Not present at garage areas, Not present at all kitchen areas, Not present at all exterior areas, Missing at bar area, Not present at all bathrooms missing at half bath, not present at all required areas in laundry and at dishwasher now required as of 2014,

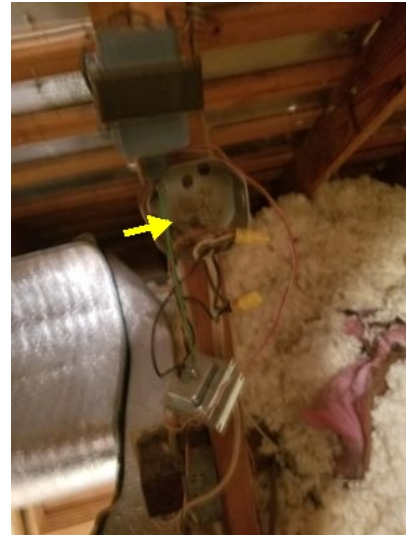
Missing junction box covers at attic area.

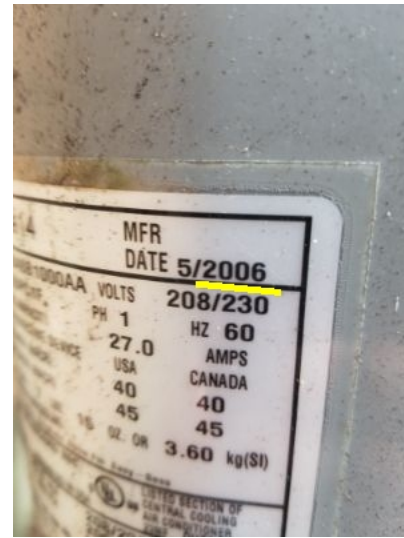
Manufactured year of condensing unit is 2006 unit is about 12 years old recommend home warranty due to age of unit.

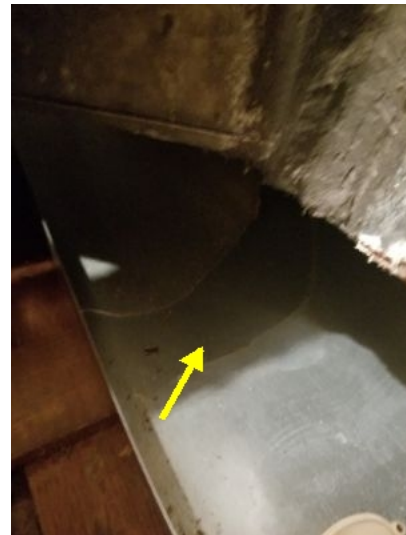
Water present at drain pan. Recommend HVAC technician evaluate.

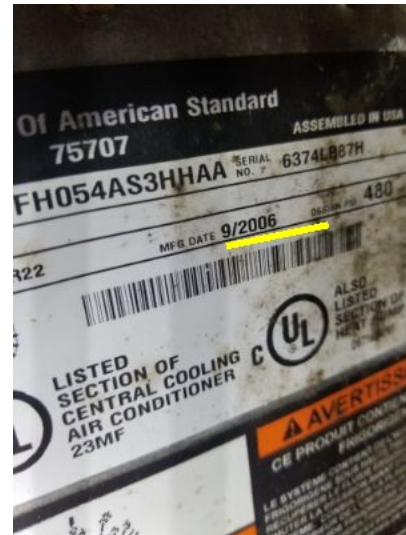
Manufactured year of evaporating coil is 2006  
unit is about 12 years old recommend home  
warranty due to age of unit.

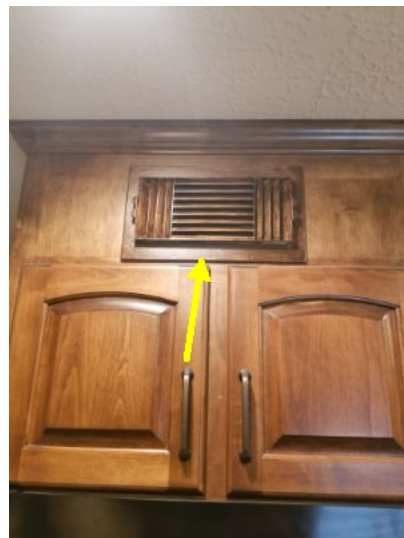
Air flow weak / or air is not very cool at kitchen register and upstairs front left bedroom( if viewed by facing home from street), and upstairs back bedroom. Recommend HVAC technician evaluate.

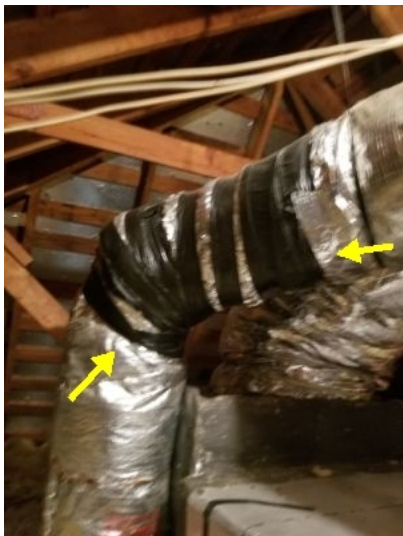
Electrical tape present at duct should be a/c tape.

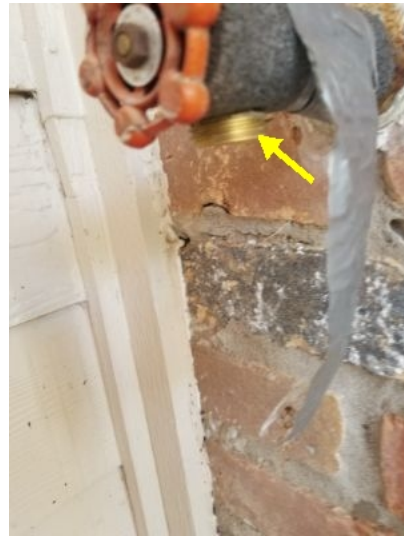
Missing back flow preventer device at hose bibbs.

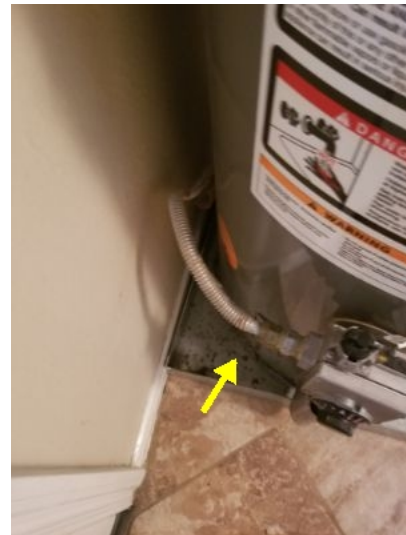
Sediment trap is missing for the gas supply line at the water heating unit. Sediment traps (T fitting with a short leg in the down position) are intended to trap moisture in the gas supply line

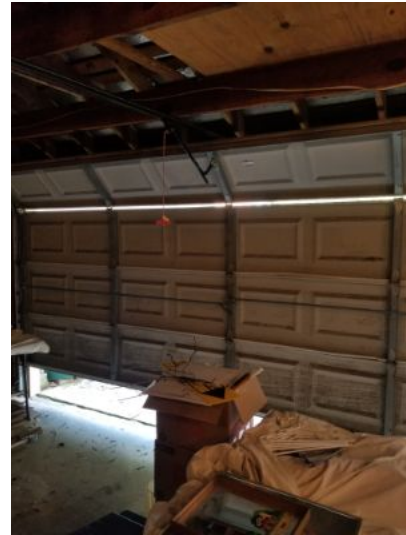
Auto reverse mechanism is not present or did not function at garage door.

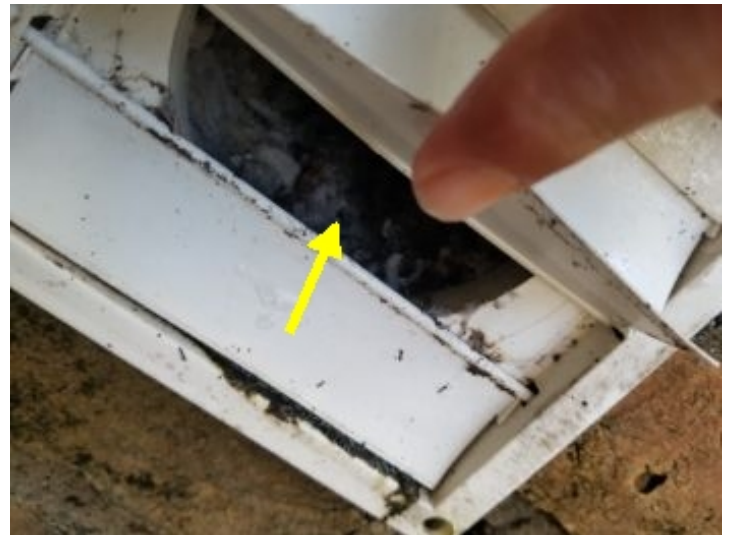
Recommend lint removal. Lint in vent can be a fire hazard.

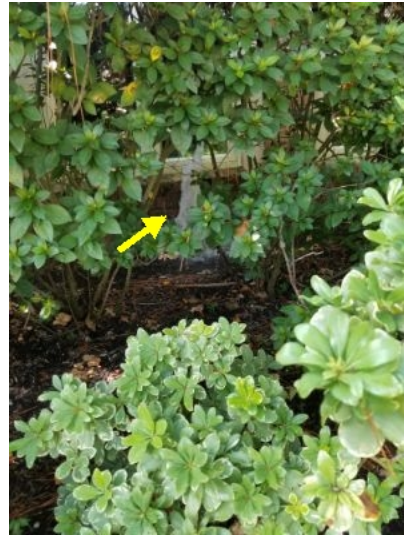
Broken sprinkler heads at front and back yard areas.
