## Property Inspection Report

19139 Candletrail Dr., Spring, TX 77388

Date of Inspection: 10/5/2018 Time: 10:00 a.m.- 1:27 p.m.

Inspector: John Fish

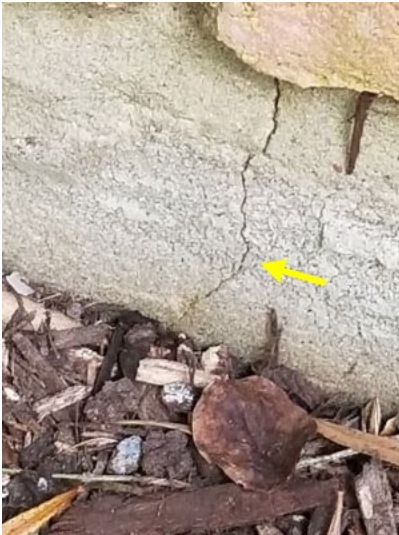
Observed damaged corners of the slab. "Corner pops" typically occur due to different thermal expansion rates between the wall and foundation. Because the foundation reinforcement does not extend into the corners, these areas are weaker than the surrounding masonry and crack under expansive pressure. These cracks are common and do not affect foundation performance

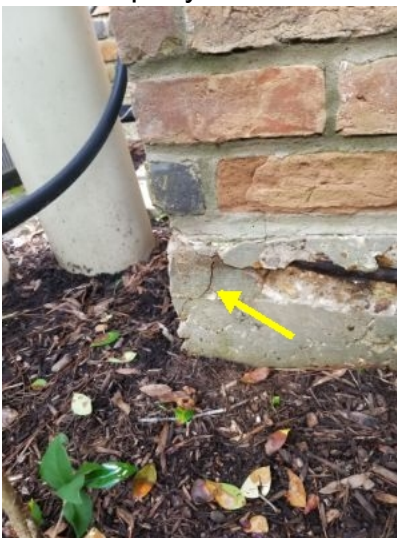
Observed damaged corners of the slab. "Corner pops" typically occur due to different thermal expansion rates between the wall and foundation. Because the foundation reinforcement does not extend into the corners, these areas are weaker than the surrounding masonry and crack under expansive pressure. These cracks are common and do not affect foundation performance

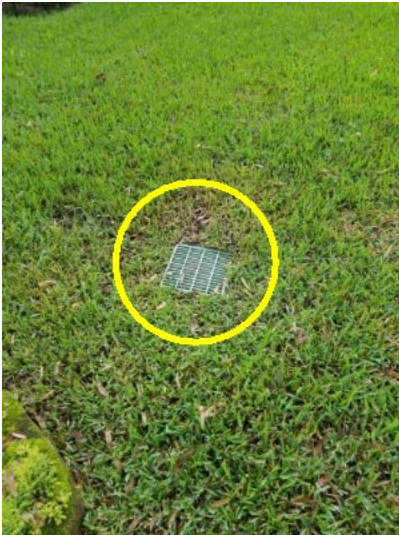
Drains present

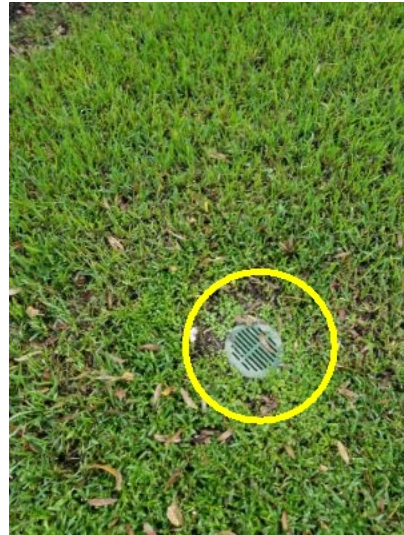
Drains not tested by inspector

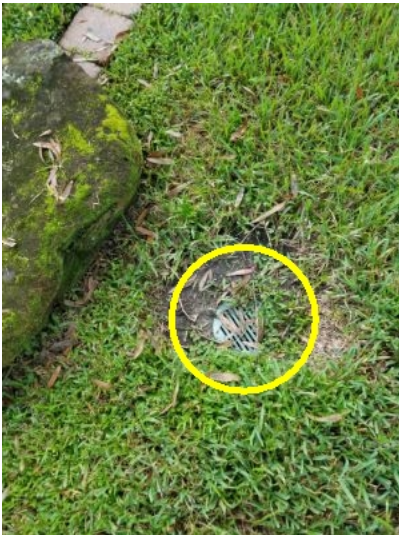
Drains not tested by inspector

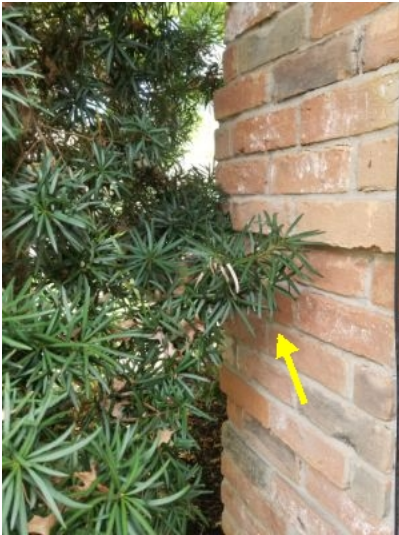
Extensive vegetation next to the home or growing on the home can promote moisture damage and wood deterioration to the siding and structure. It is recommended to keep all vegetation away from the home to allow proper ventilation between the home and vegetation • Wood form boards and /or stakes around foundation should be removed as they will tend to rot and may attract termites

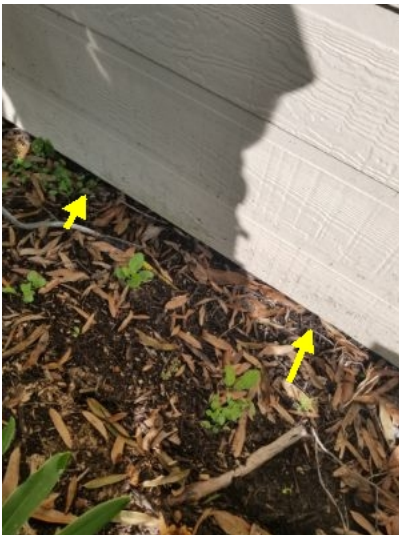
There are areas around the foundation that have high soil, Which can be conducive to termites and allow water/insects into home. Soil grade should typically be four to six inches below the top of foundation with a positive slop away from the foundation for proper drainage.

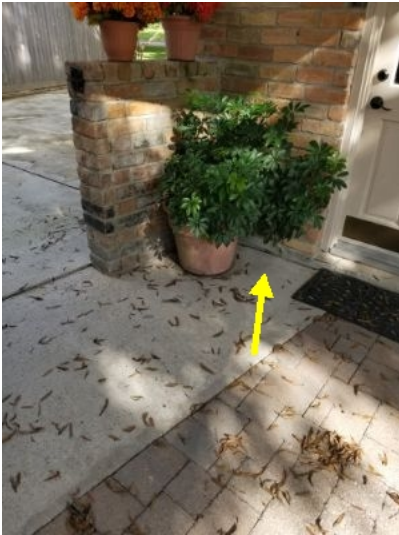
Soil grade and drainage patterns around some areas of house do not appear to properly direct water away from foundation to aid in controlling runoff water and could cause differential movement of the foundation or water penetration during heavy rains.( Back of home and back area of garage.)

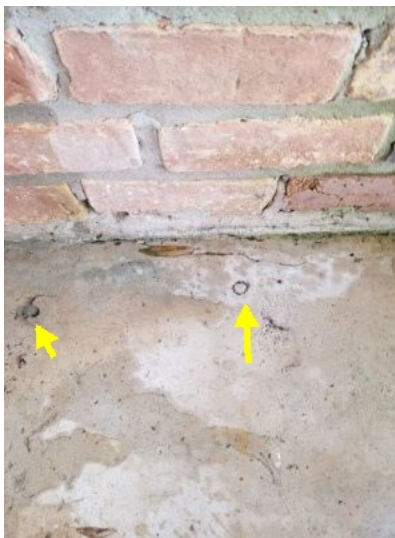
Appears home has been treated for termites in past recommend consulting with seller about the date of treatment and if there are any warranties in place.

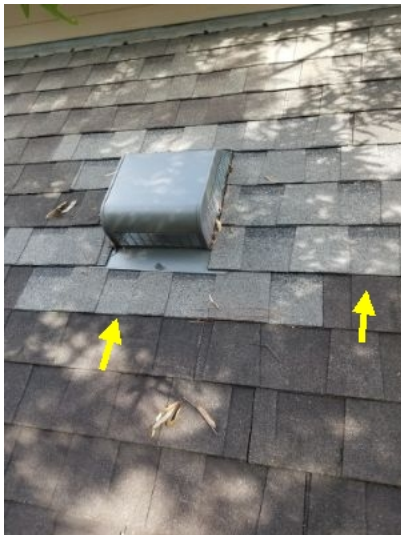
Observed repaired areas where newer shingles where installed in areas.

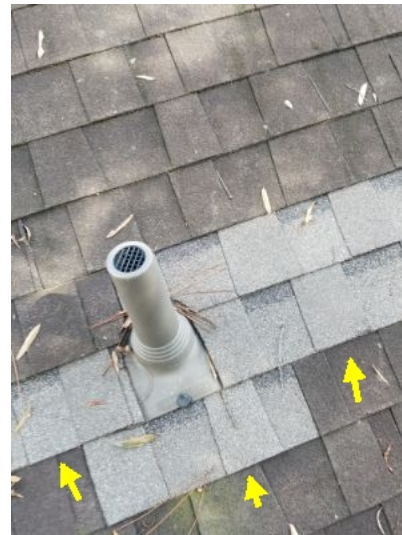
Observed repaired areas where newer shingles where installed in areas.

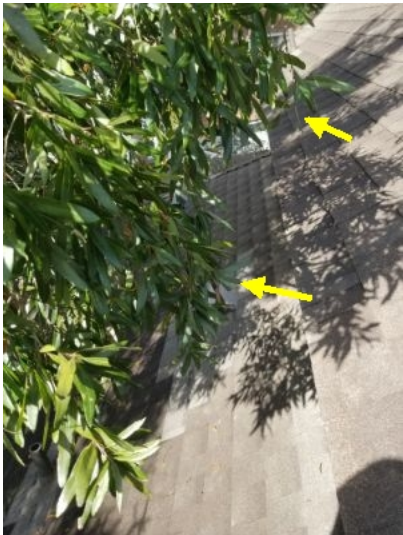
Recommend trimming tree limbs three to five feet away from roof coverings.

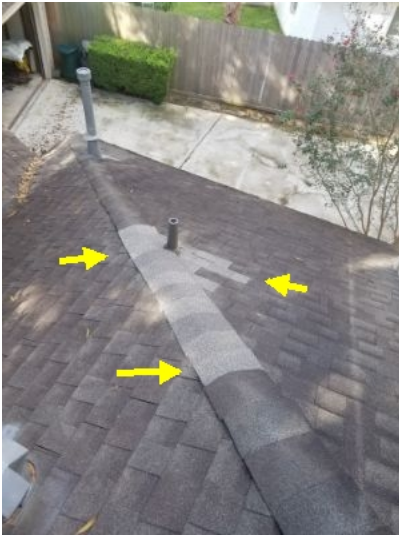
Observed repaired areas where newer shingles where installed in areas.

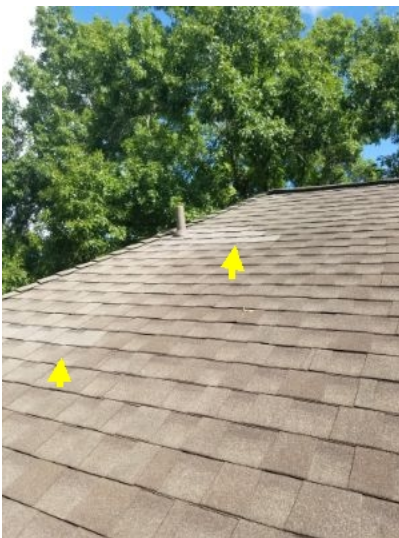
Observed repaired areas where newer shingles where installed in areas.

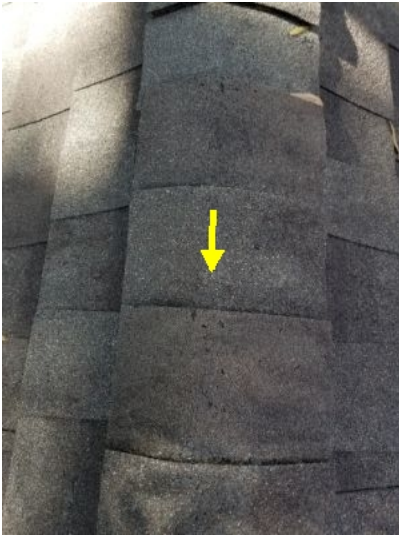
Granular loss observed at ridge cap shingles in areas.

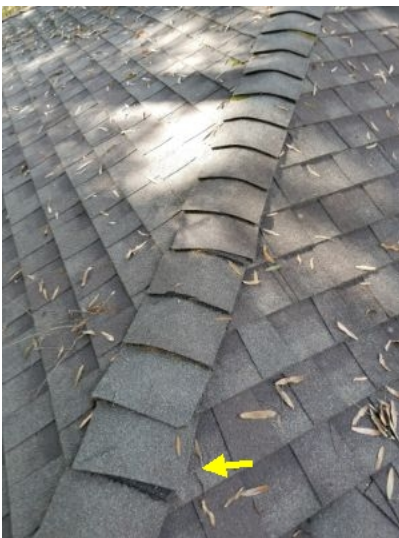
Observed a loose ridge cap shingle at garage area.

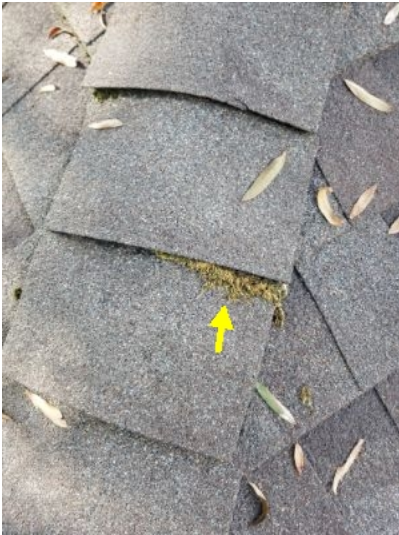
Observed moss growing on shingles in areas.

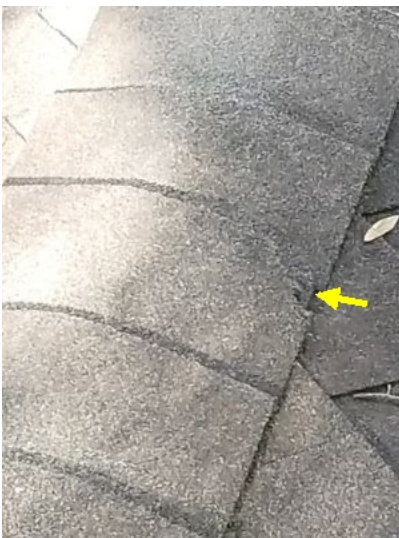
Damaged ridge cap shingles observed in areas.

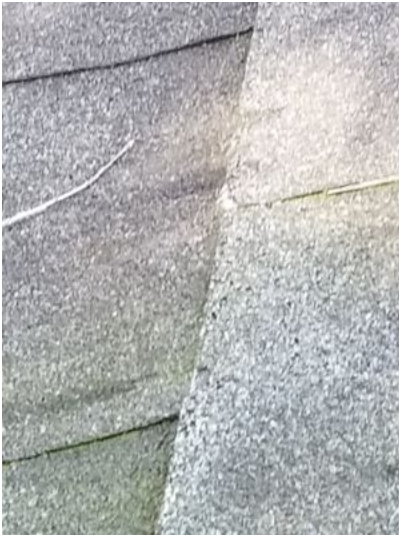
Granular loss observed at shingles.

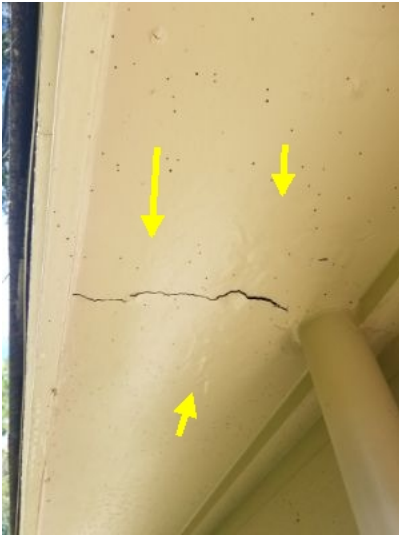
Observed moisture damaged soffits in more than one areas recommend contactor evaluate and repair.

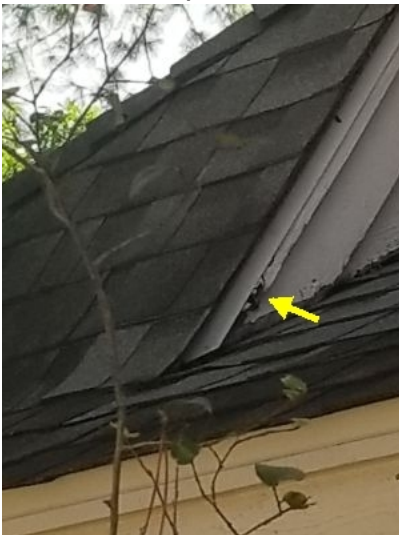
Wood rot observed at fascia board at one or more areas.

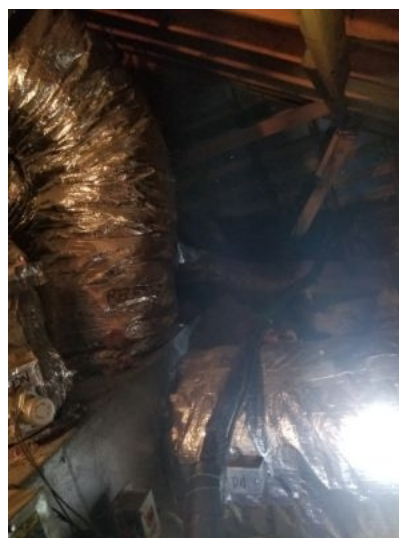
Missing collar ties in areas.

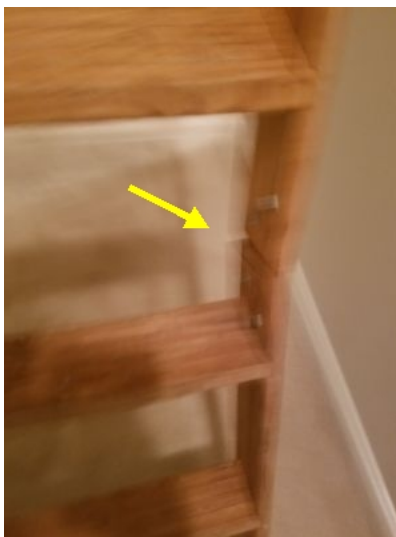
Attic access opening is not cut properly and it is difficult to enter into attic area due to position of pull down access stairs.

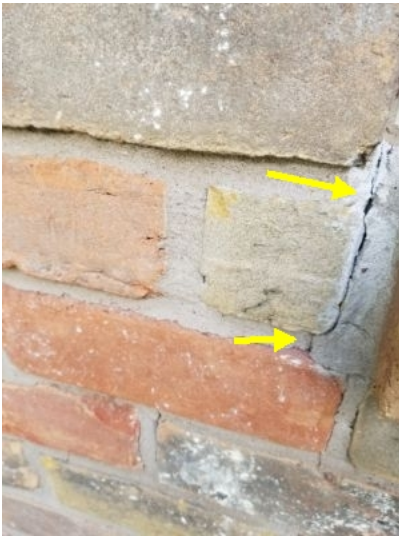
Observed mortar cracks in areas.

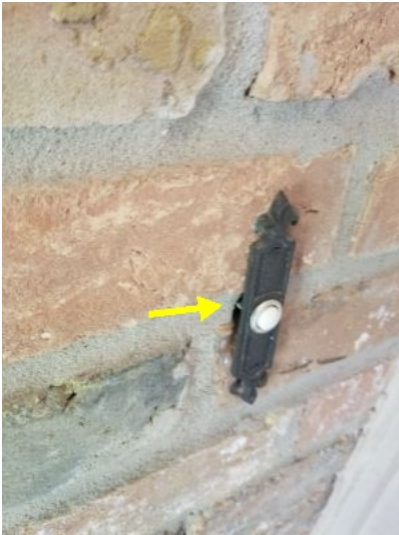
Recommend sealing all holes and gaps at exterior.

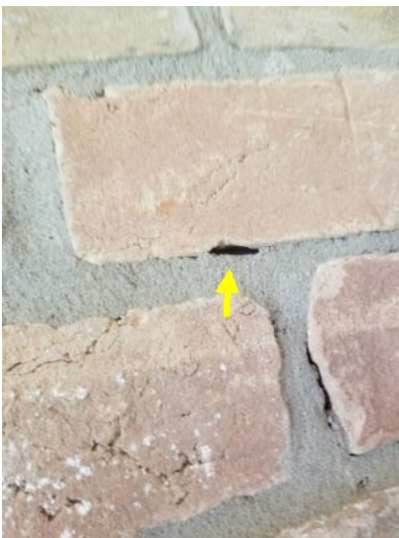
Missing mortar at one or more areas.

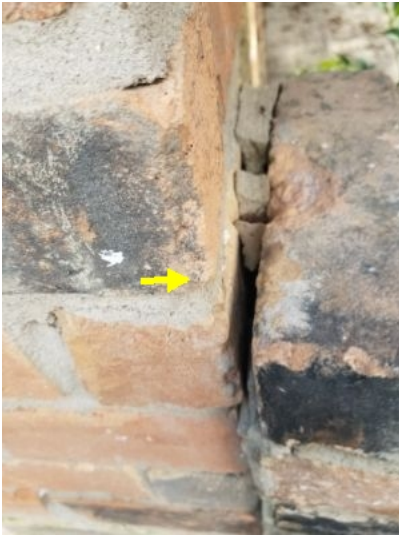
The brick wall at back of home attached missing mortar and separating from home,

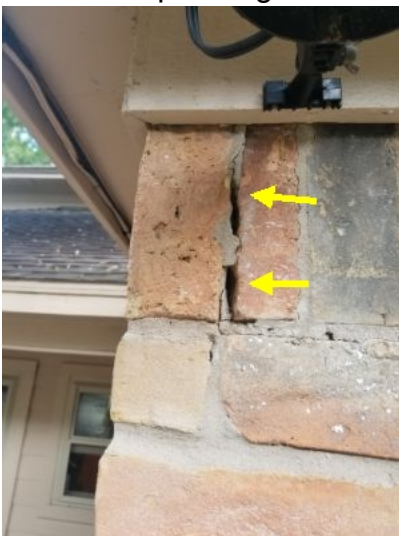
Missing mortar at one or more areas.

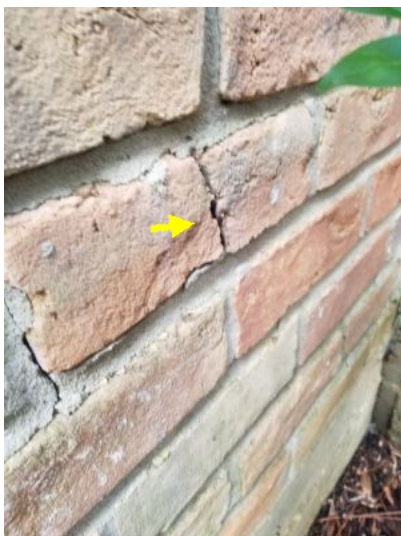
Cracks observed in brick veneer in areas.

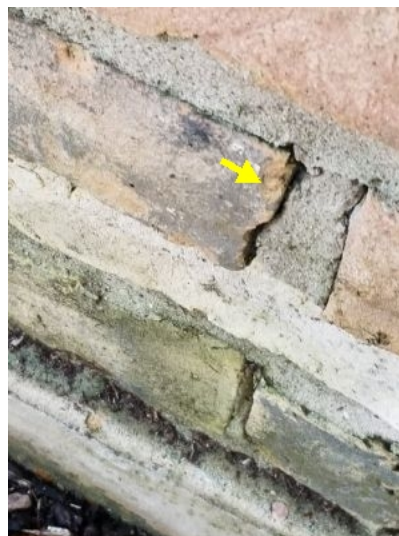
Observed mortar cracks in areas.

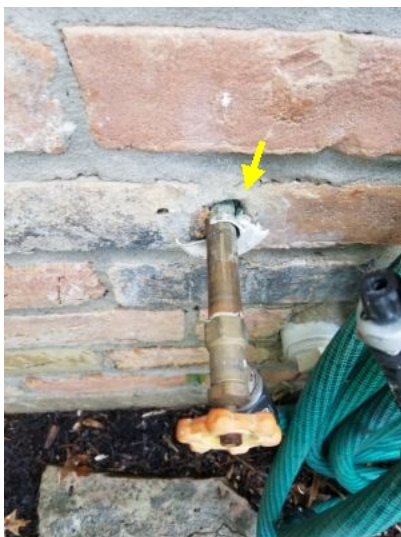
Recommend sealing around all penetrations at exterior areas.

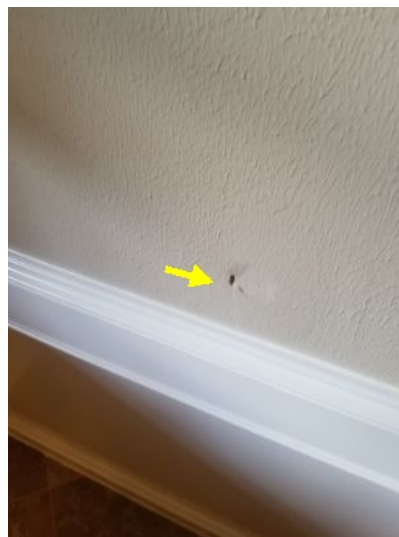
Small hole observed in breakfast area wall.

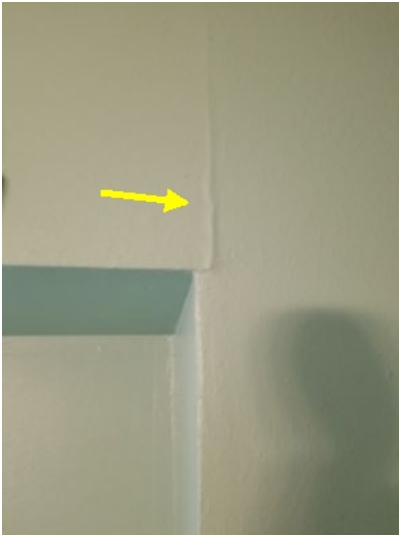
Cracks or repaired cracks observed in drywall in areas.

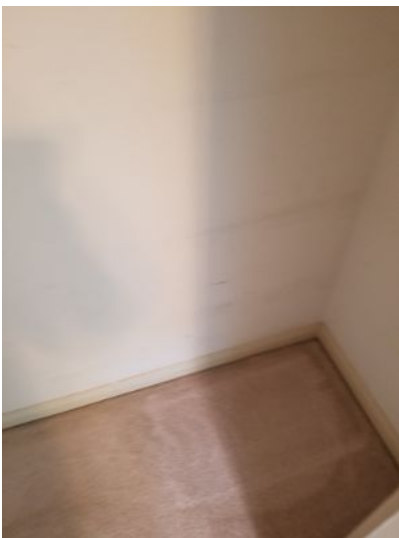
Paint needs touched up in areas.

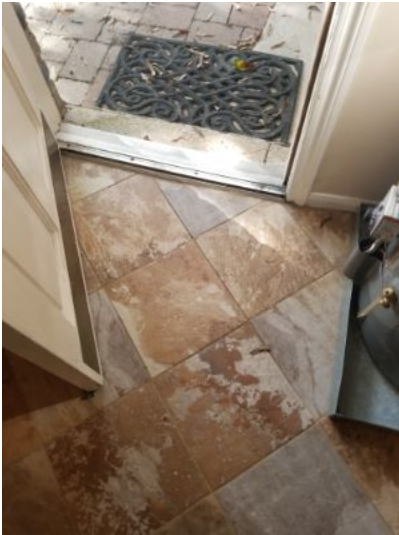
Tile did not appear to bond well to concrete at breakfast area and laundry room areas recommend contractor evaluate.

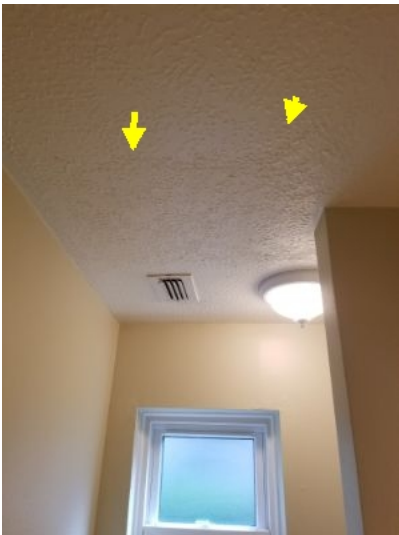
Patched areas on the ceiling

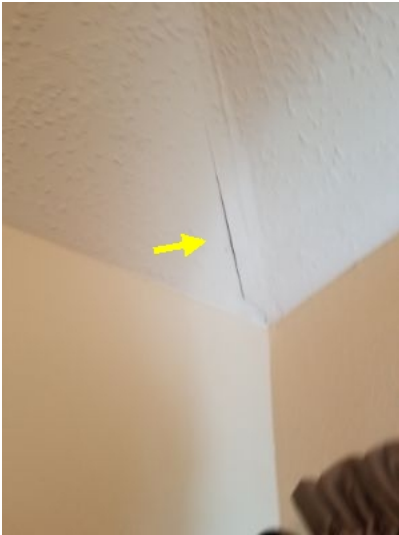
Cracks observed in drywall on ceiling

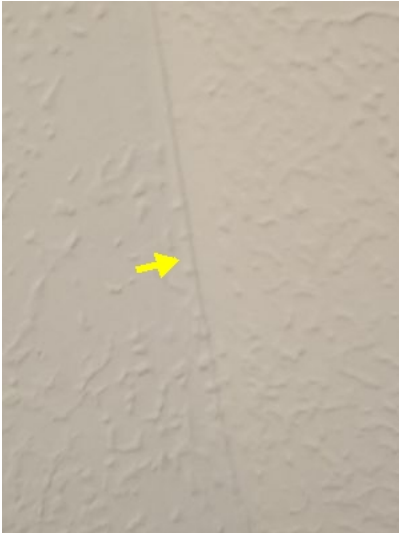
Cracks observed in drywall on ceiling

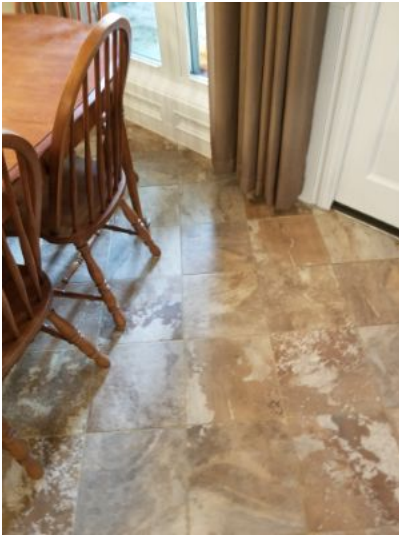
Tile did not appear to bond well to concrete at breakfast area and laundry room areas recommend contractor evaluate.

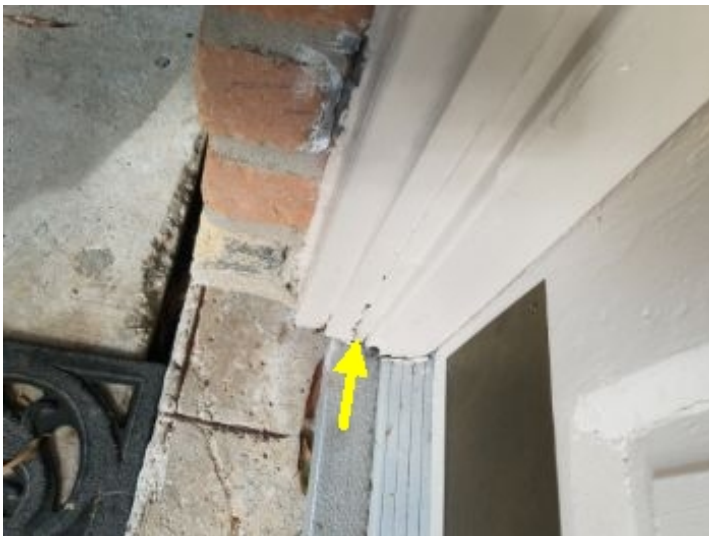
Observed some damage at back door jamb laundry room entry door.

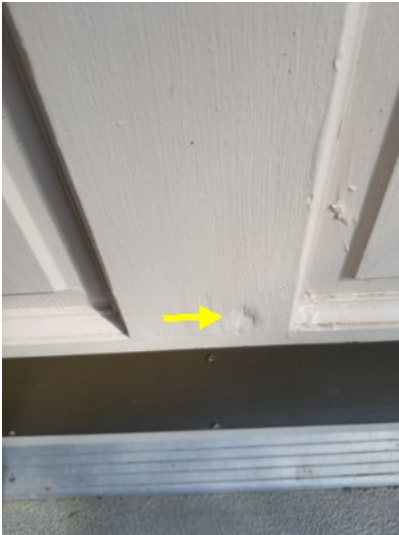
Wood rot observed at back door entry into laundry room area.

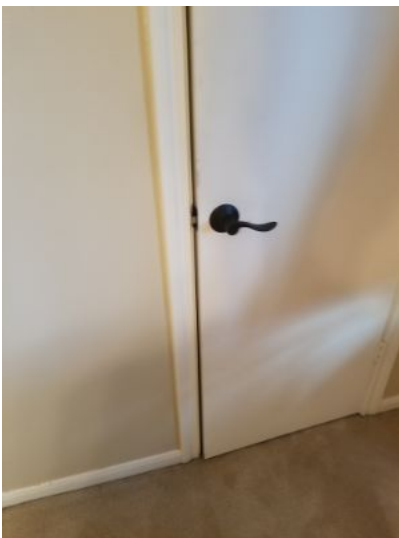
Doors did not latch at one or more areas.

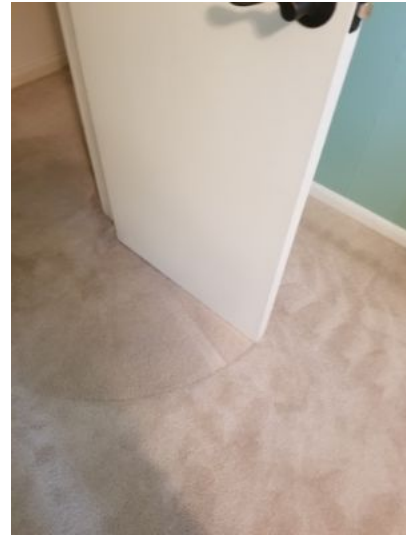
Door drags at floor at upstairs front right bedroom (if viewed by facing home from street.) closet door.

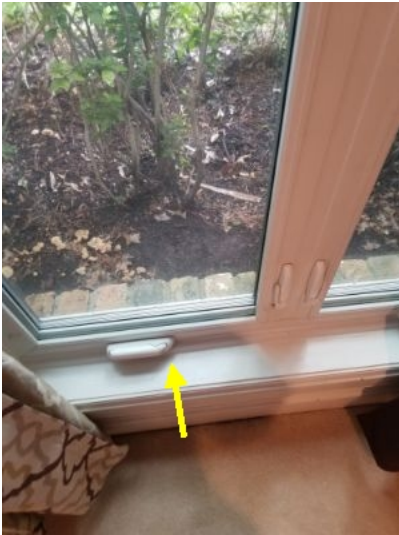
Some of the windows that open with hand crank stick, but do function.

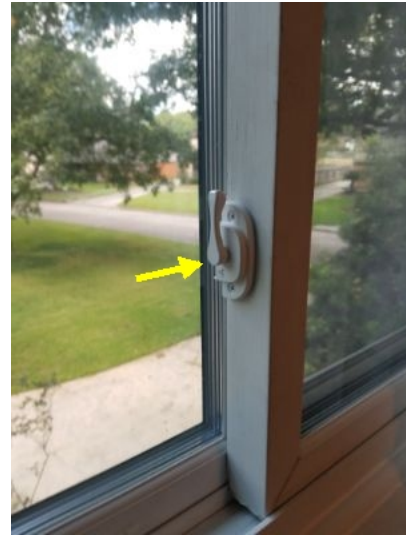
Upstairs front right bedroom ( If viewed by facing home from street) window did not latch.

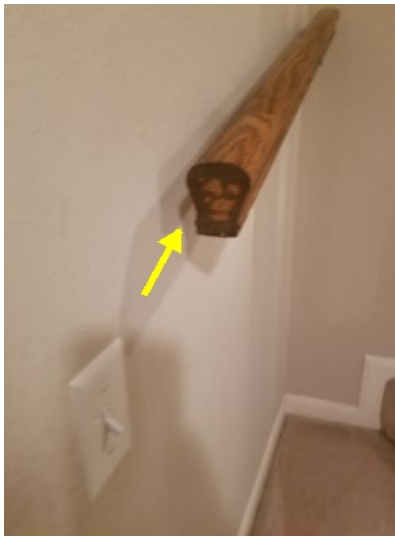
Hand rail should return to wall.

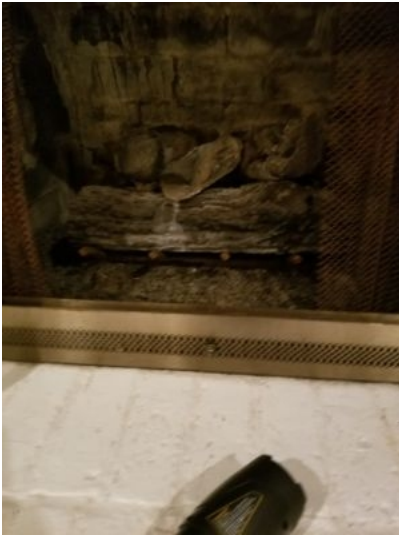
Gas logs present damper should be blocked open.

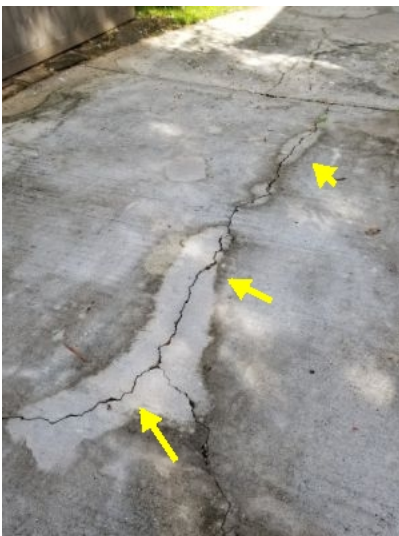
Cracks observed on driveway

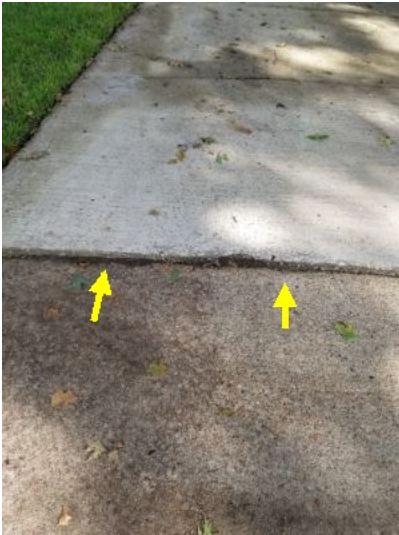
lifting area at driveway this can create a trip hazard.

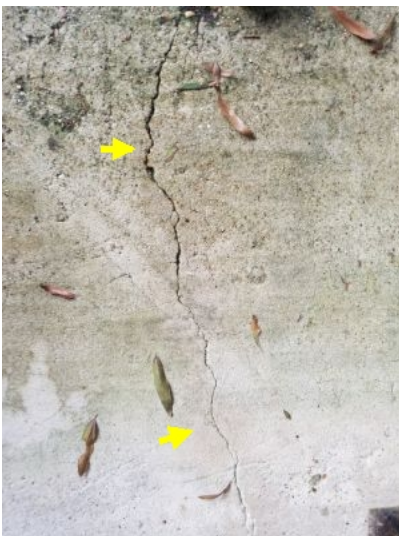
cracking seen on the patio

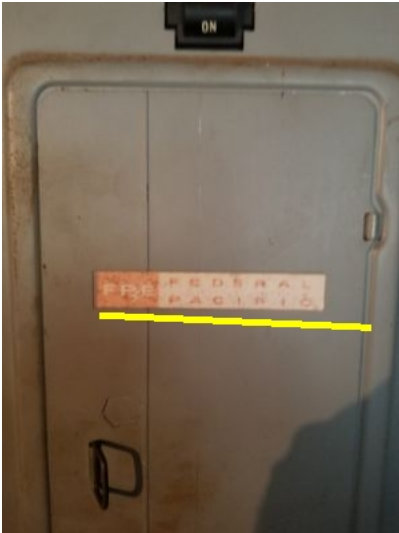
I have observed a federal Pacific stab lok sub panel

The following has been said about Federal Pacific Electric "Stab-Lok" panels:

That these panels pose a latent threat and could be a hazard. The circuit breakers may fail to trip in the case of an overload or short-circuit. A circuit breaker that fails to trip could cause a fire or personal injury. For these reasons and the potential risk I recommend that these types of panels be replaced by a certified and licensed electrician

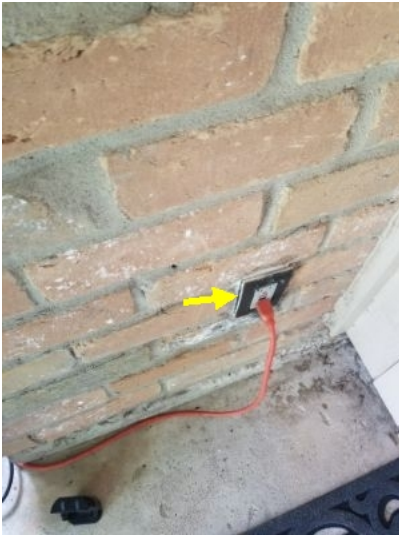
Missing weather proof hood cover at front porch area.

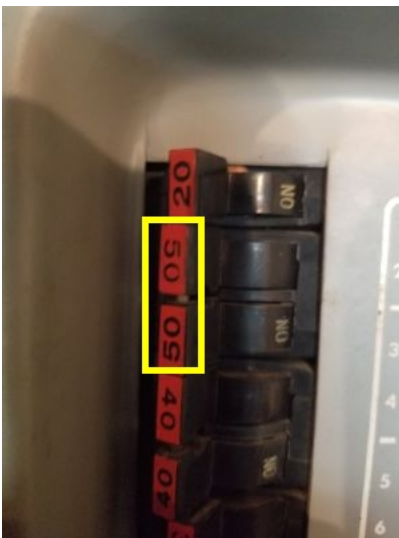
The breaker for the A/C condensing unit is 50 amps. The maximum rated fuse or breaker on the air conditioning unit is 45 amps, meaning that the breaker in the panel is too large for the unit. This could be a fire hazard and I recommend further evaluation by a licensed electrician

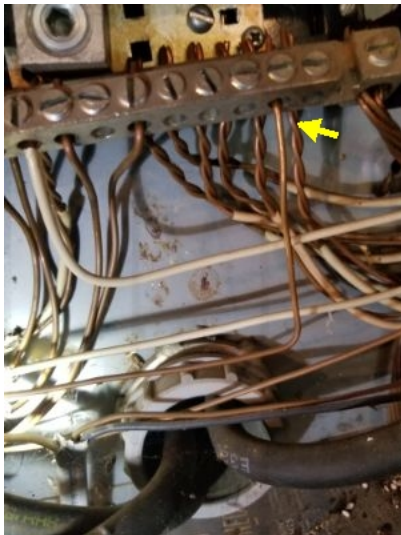
There are neutral and ground wires in the panel that are sharing spots on the buss bar

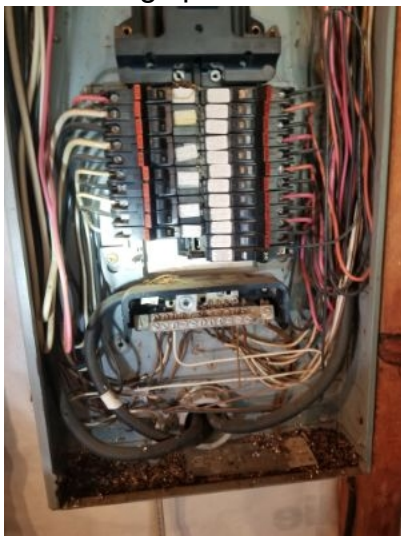
Did not observe installed AFCI (Arc Fault Circuit Interrupt) device protection, as required by current building standards, for all: family rooms, dining rooms, living rooms, parlors, libraries, dens, bedrooms, sunrooms, recreation rooms, closets, hallways, or similar rooms or areas. AFCI devices are intended to protect against fires caused by electrical arcing faults in the home's wiring. Arc faults are a common cause of residential electrical fires. Arc faults can be created by damaged, deteriorated, or worn electrical plugs, cords, and/or branch circuit conductors. As of September 1, 2008, the State of Texas has adopted the 2008 NEC.

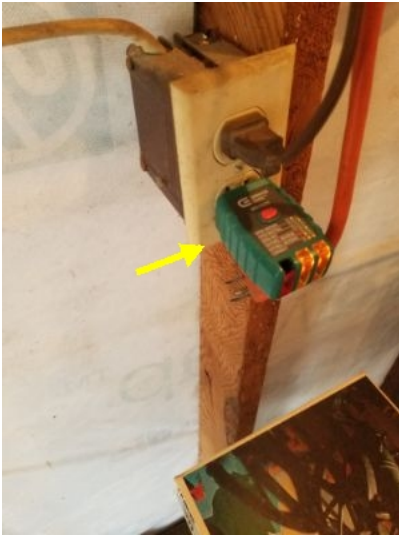
Not all outlets in hazardous locations are protected with GFCI circuitry as required by current standards. Observed one or more of the following required locations that are not GFCI protected: all bathrooms, all kitchen counter top and island outlets, all exterior outlets, garage outlets, etc. This condition is a recognizee hazard and should be corrected by a qualified/licensed electrician. One or more outlets in the following locations were not protected: Not present at garage areas, Not present at all kitchen areas, Not present at all exterior areas, Missing at bar area, Not present at all bathrooms missing at half bath, not present at all required areas in laundry and at dishwasher now required as of 2014,

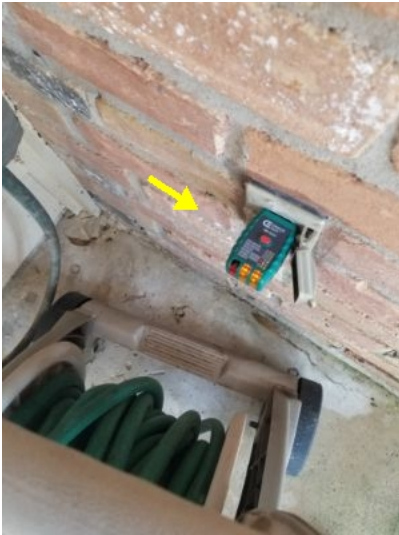
Not all outlets in hazardous locations are protected with GFCI circuitry as required by current standards. Observed one or more of the following required locations that are not GFCI protected: all bathrooms, all kitchen counter top and island outlets, all exterior outlets, garage outlets, etc. This condition is a recognizee hazard and should be corrected by a qualified/licensed electrician. One or more outlets in the following locations were not protected: Not present at garage areas, Not present at all kitchen areas, Not present at all exterior areas, Missing at bar area, Not present at all bathrooms missing at half bath, not present at all required areas in laundry and at dishwasher now required as of 2014,

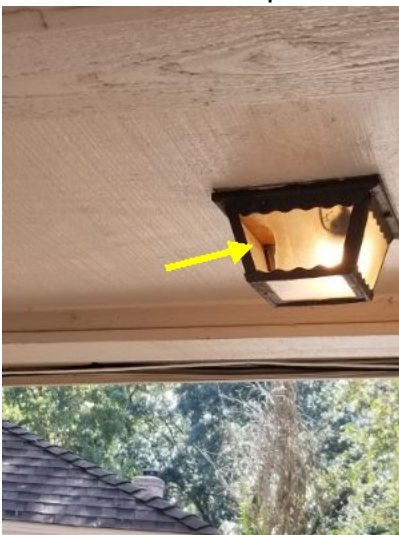
Damaged light fixture cover at back breezeway area.

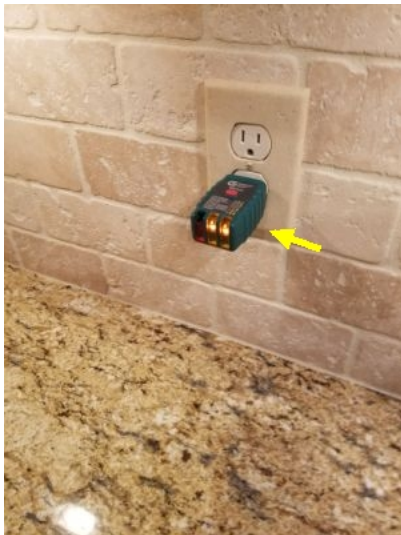
Not all outlets in hazardous locations are protected with GFCI circuitry as required by current standards. Observed one or more of the following required locations that are not GFCI protected: all bathrooms, all kitchen counter top and island outlets, all exterior outlets, garage outlets, etc. This condition is a recognizee hazard and should be corrected by a qualified/licensed electrician. One or more outlets in the following locations were not protected: Not present at garage areas, Not present at all kitchen areas, Not present at all exterior areas, Missing at bar area, Not present at all bathrooms missing at half bath, not present at all required areas in laundry and at dishwasher now required as of 2014,

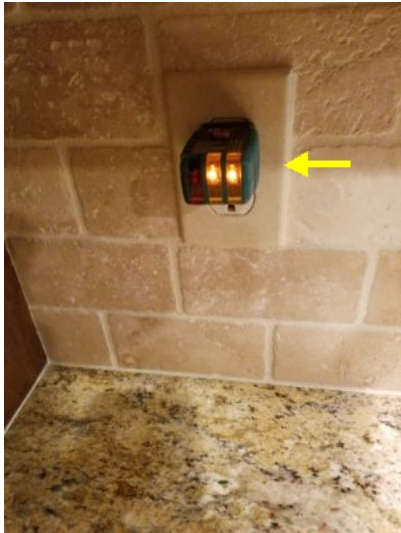
Not all outlets in hazardous locations are protected with GFCI circuitry as required by current standards. Observed one or more of the following required locations that are not GFCI protected: all bathrooms, all kitchen counter top and island outlets, all exterior outlets, garage outlets, etc. This condition is a recognizee hazard and should be corrected by a qualified/licensed electrician. One or more outlets in the following locations were not protected: Not present at garage areas, Not present at all kitchen areas, Not present at all exterior areas, Missing at bar area, Not present at all bathrooms missing at half bath, not present at all required areas in laundry and at dishwasher now required as of 2014,

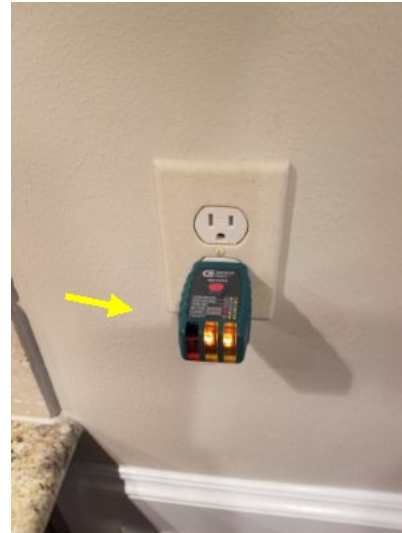
Not all outlets in hazardous locations are protected with GFCI circuitry as required by current standards. Observed one or more of the following required locations that are not GFCI protected: all bathrooms, all kitchen counter top and island outlets, all exterior outlets, garage outlets, etc. This condition is a recognizee hazard and should be corrected by a qualified/licensed electrician. One or more outlets in the following locations were not protected: Not present at garage areas, Not present at all kitchen areas, Not present at all exterior areas, Missing at bar area, Not present at all bathrooms missing at half bath, not present at all required areas in laundry and at dishwasher now required as of 2014,

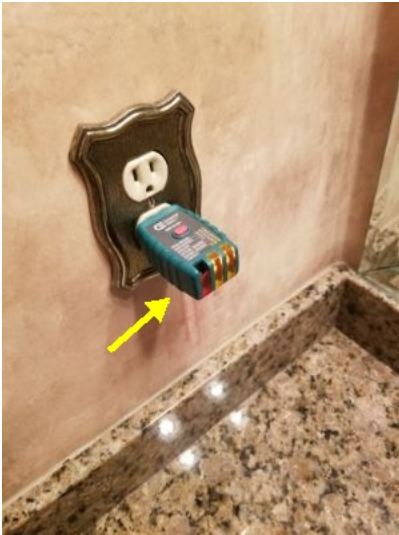
Not all outlets in hazardous locations are protected with GFCI circuitry as required by current standards. Observed one or more of the following required locations that are not GFCI protected: all bathrooms, all kitchen counter top and island outlets, all exterior outlets, garage outlets, etc. This condition is a recognizee hazard and should be corrected by a qualified/licensed electrician. One or more outlets in the following locations were not protected: Not present at garage areas, Not present at all kitchen areas, Not present at all exterior areas, Missing at bar area, Not present at all bathrooms missing at half bath, not present at all required areas in laundry and at dishwasher now required as of 2014,

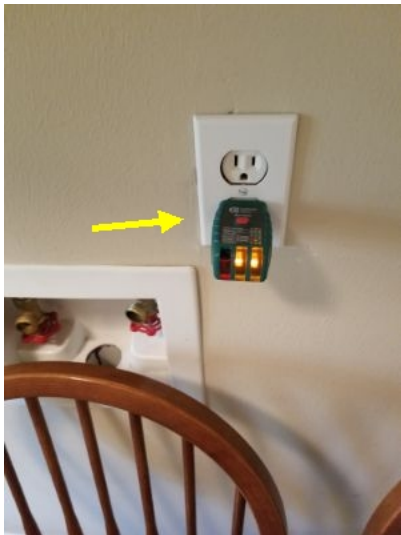
Not all outlets in hazardous locations are protected with GFCI circuitry as required by current standards. Observed one or more of the following required locations that are not GFCI protected: all bathrooms, all kitchen counter top and island outlets, all exterior outlets, garage outlets, etc. This condition is a recognizee hazard and should be corrected by a qualified/licensed electrician. One or more outlets in the following locations were not protected: Not present at garage areas, Not present at all kitchen areas, Not present at all exterior areas, Missing at bar area, Not present at all bathrooms missing at half bath, not present at all required areas in laundry and at dishwasher now required as of 2014,

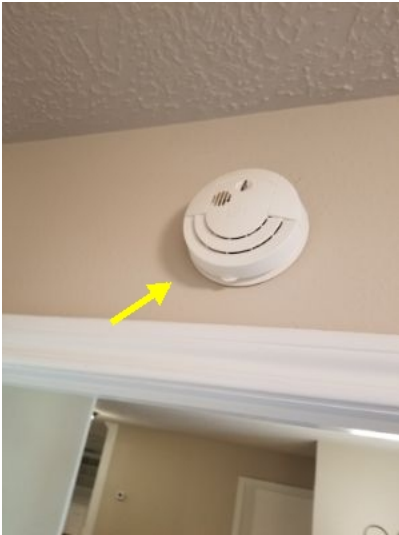
This house does not appear to be equipped with enough smoke detectors. We strongly advise investing in multiple detectors and placing them according to the manufacturer's instructions. Smoke detectors should be placed within each bedroom, outside each sleeping area, and on each additional story (No smoke detectors located in sleeping areas and smoke detectors found at adjacent areas are old and would recommend replacement).

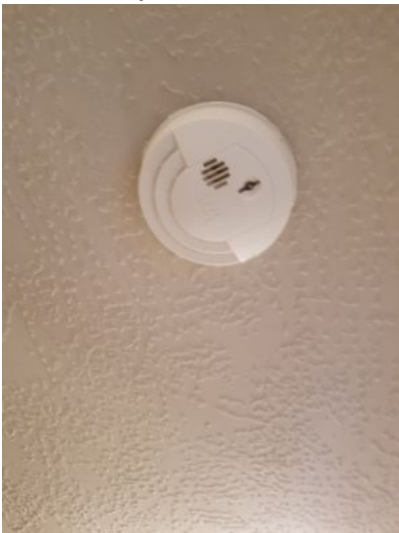
This house does not appear to be equipped with a carbon monoxide detector. We strongly advise investing in at least one detector and placing it according to the manufacturer's instructions.

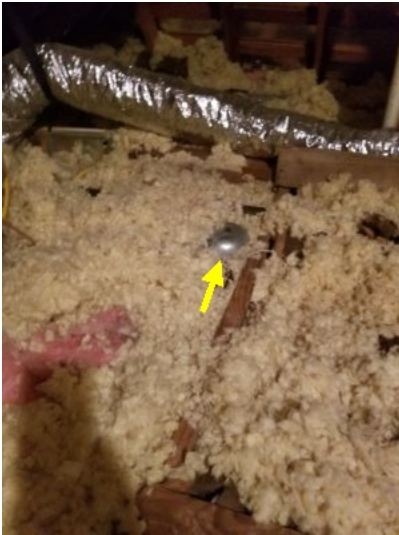
Can light in contact with insulation recommend removing insulation 2'

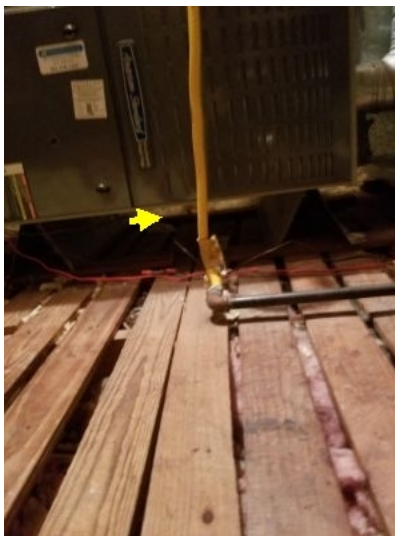
Sediment trap is missing for the gas supply line at the heating unit. Sediment traps (T fitting with a short leg in the down position) are intended to trap moisture in the gas supply line

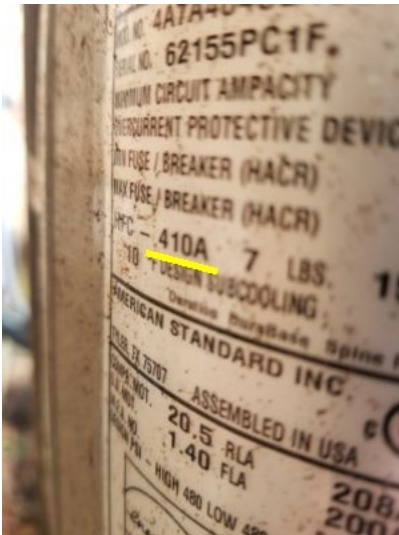
The condensing unit says that unit is 410A refrigerant and evaporating coil says R22 recommend HVAC technician evaluate and determine what type of refrigerant units are using because R22 will not be available much longer.

After R22 becomes illegal on January 1, 2020, older R22 systems become obsolete and can no longer be repaired when the repair would require adding refrigerant to the system. Except for some simple electrical issues, many types of repairs do require recharging refrigerant. You've probably guessed that fixing a refrigerant leak will be out of the question. Recommend a home warranty that will cover replacement of a a/c system that uses R-22 coolant and begins leaking this coolant in the future.

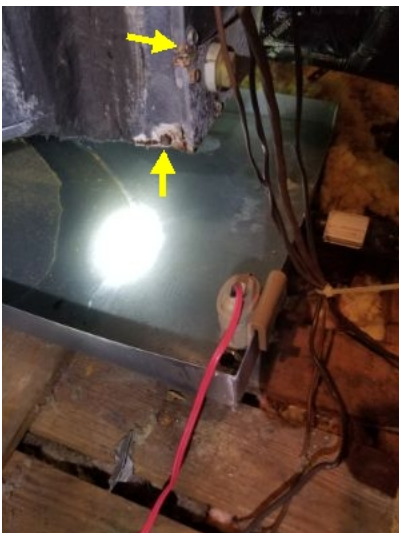
Rust present at evaporating coil.

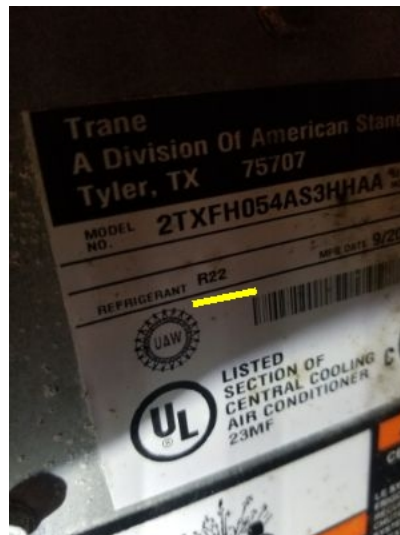
The condensing unit says that unit is 410A refrigerant and evaporating coil says R22 recommend HVAC technician evaluate and determine what type of refrigerant units are using because R22 will not be available much longer. After R22 becomes illegal on January 1, 2020, older R22 systems become obsolete and can no longer be repaired when the repair would require adding refrigerant to the system. Except for some simple electrical issues, many types of repairs do require recharging refrigerant. You've probably guessed that fixing a refrigerant leak will be out of the question. Recommend a home warranty that will cover replacement of a a/c system that uses R-22 coolant and begins leaking this coolant in the future.

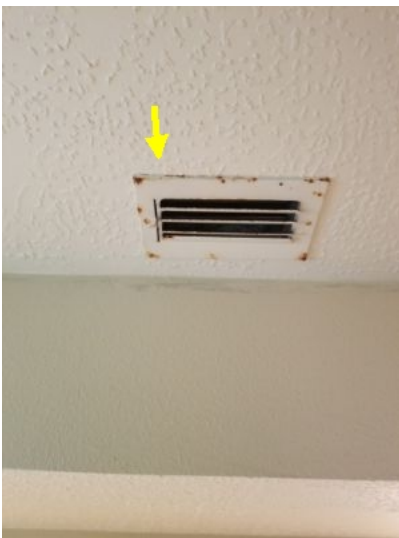
Registers are rusted at one or more areas.

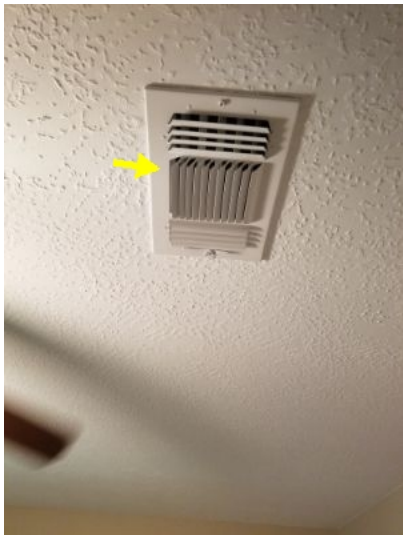
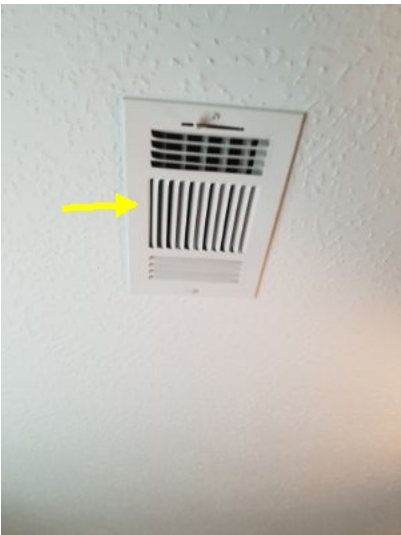
Air flow weak / or air is not very cool at kitchen register and upstairs front left bedroom( if viewed by facing home from street), and upstairs back bedroom. Recommend HVAC technician evaluate.

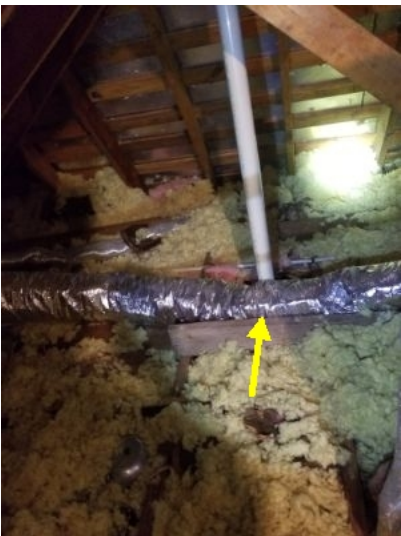
Ducts not suspended in areas.

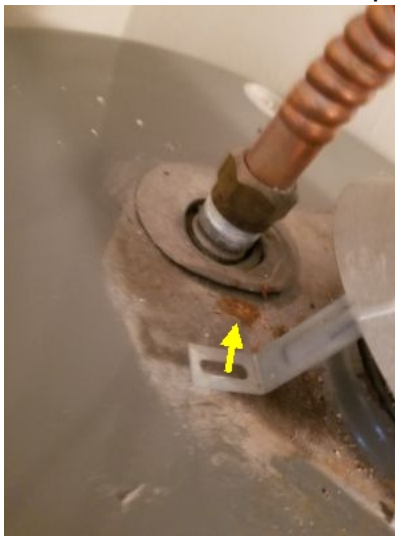
Corrosion present at the top of water heater.

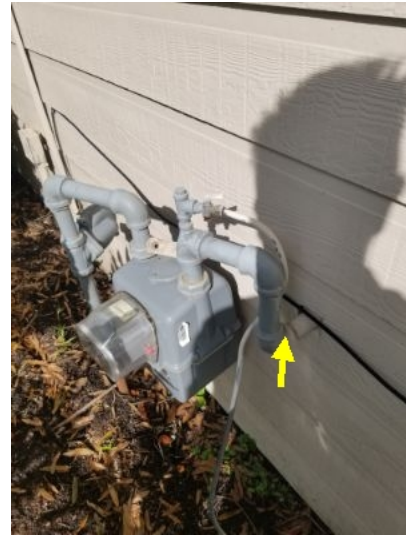
Bonding wire is not present at gas meter.

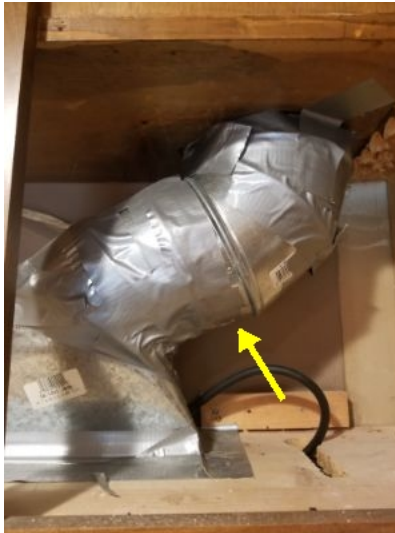
Duct tape present at duct should be a/c tape.

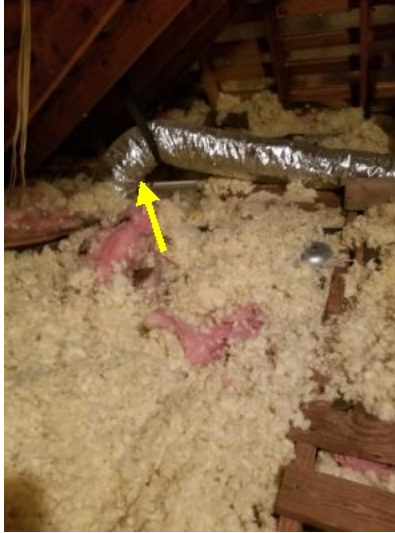
One or more bath fan terminates improperly in the attic. This can create excessive moisture. Recommend directing the vent towards the exterior to allow for proper ventilation.

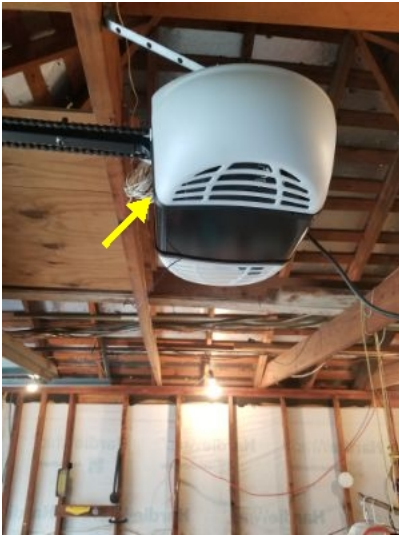
Light bulb is burned out

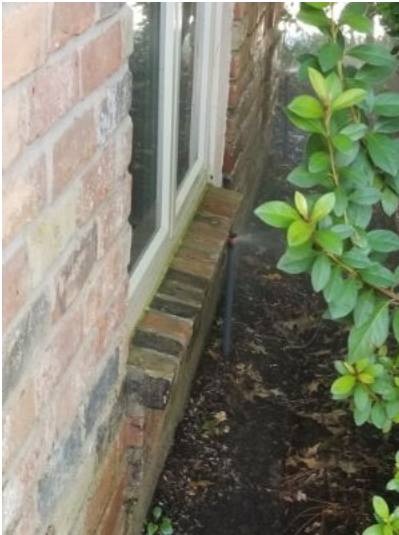
Heads need adjustment in some areas spraying structure at one or more areas.

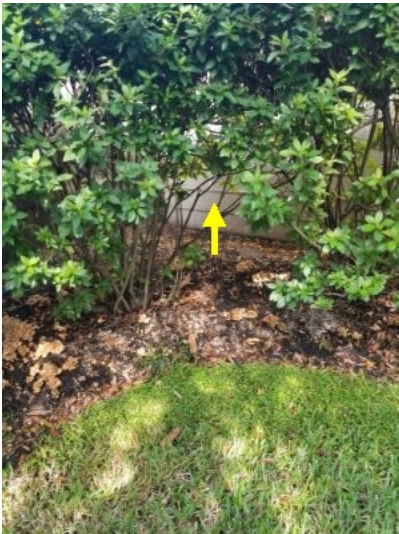
Heads need adjustment in some areas spraying structure at one or more areas.

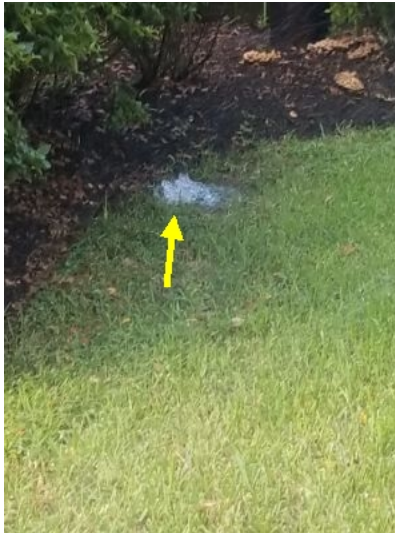
Broken sprinkler heads at front and back yard areas.
